Characterisation of Saline Land in the Woody Yaloak Catchment, Victoria

By Kane Church

**Research Thesis submitted as part of the B.App.Sc. (Hons)
degree within the Department of Geology**

December 2004

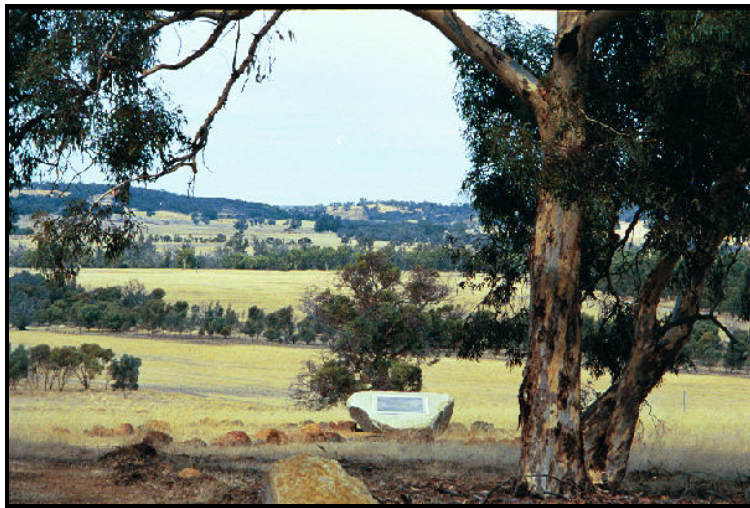
Figure 2 Deep valleys at Stan and Carol Dorman's property Lookout.

The West Dale catchment has relatively high undulating hills with deep incised flat valleys, creating the ideal situation for valley floor salting to occur (Figure 2).

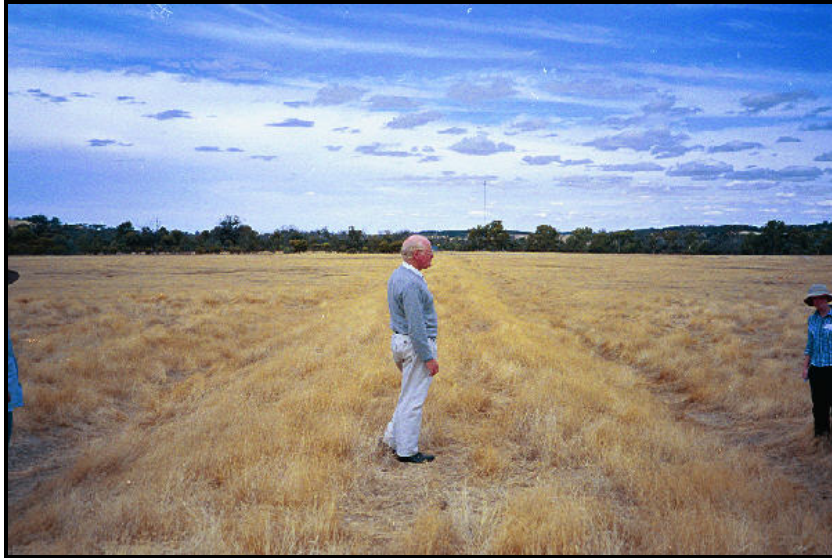
Figure 3 W-shaped drain at Stan and Carol Dorman's property.

Waterlogging has been treated on the Dorman's farm by surface water drainage. "W" and "V" shaped drains were constructed to carry water away, moving it onto the neighbouring down stream property. A W-shaped drain consists of one low lying bank (which is still able to be cropped) in the middle with a drain on either side of the bank (Figure 3). A V-shaped drain is deeper (around 1 metre) and has spoil on both or one side (Figure 4).

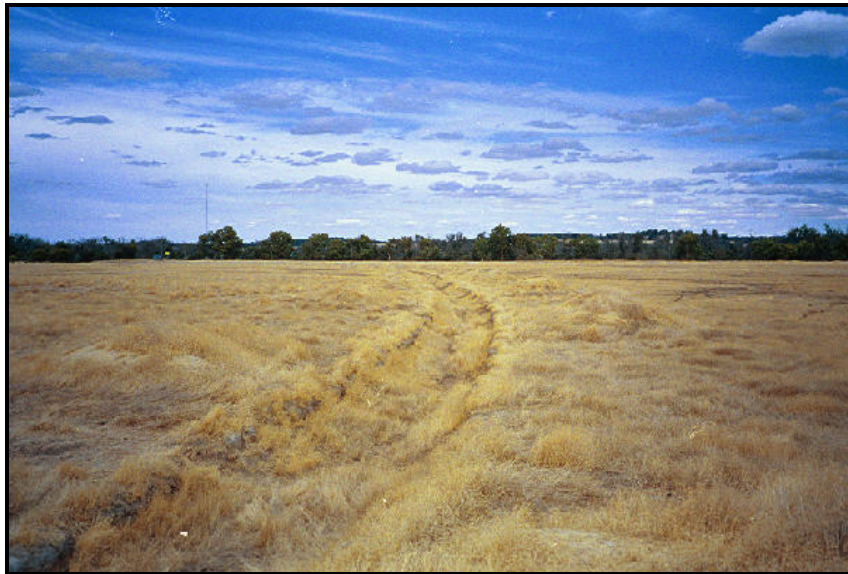
Figure 4 W-shaped drain at Stan and Carol Dorman's property.

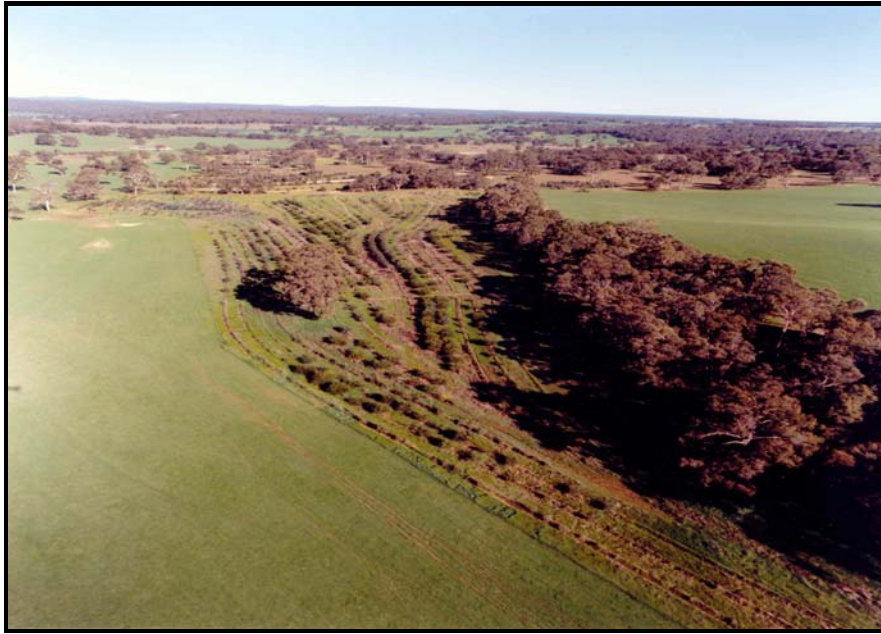
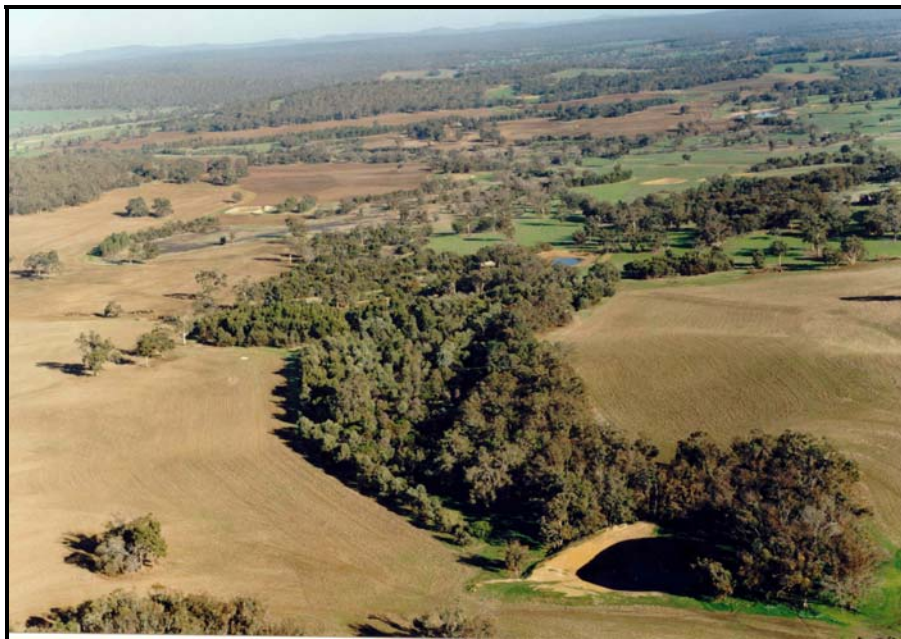
Figure 5 Stan and Carol Dorman's property, 1994.

Since 1990 when the Dorman's first started the land care project they have planted thousands of trees and carried out earth works, which have improved their property. Parts of their farm which were once waterlogged saline areas, unable to sustain sheep and with little to no cropping yield are now able to sustain sheep for a few weeks at a time and some parts are coming back into cropping rotation. The average crop yield of the West Dale catchment was 2.56 tonnes per hectare in 1990, since the implementation of minimum tillage and salinity management practices the 2002 average crop yield was 3.06 tonnes per hectare which is an increase of 19.5 percent (WDCG, 2002).

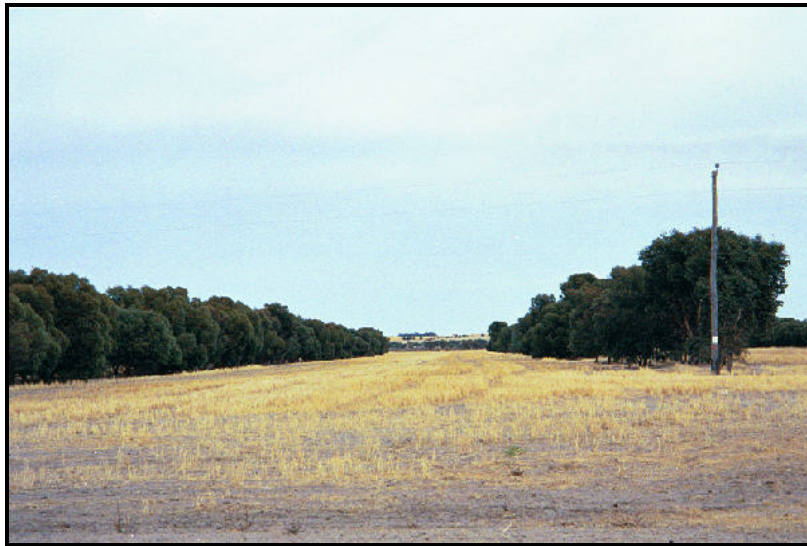
Figure 8 Alley farming.

Alley farming is used for both recharge and discharge management and involves planting two rows of trees five metres apart and with 50 metres between each two rows to allow for cropping (Figure 8).

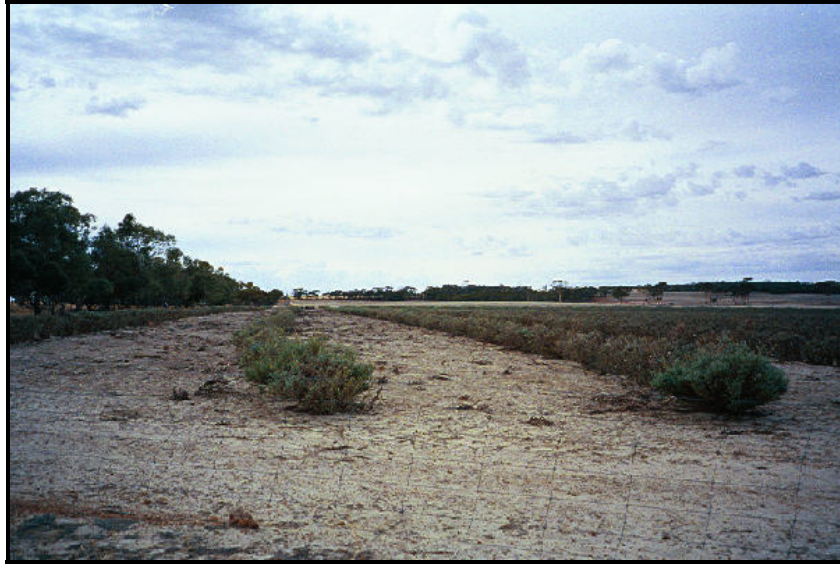
Figure 10 Tagasaste plantation.

Tagasaste, a plant similar to Lucerne but with a scrubby habit, is able to be used for grazing and is a high water-user, so it is used in recharge areas (Figure 10). At the Wendy Diamond lookout south of Tammin, Tagasaste has been established on a high recharge area. Paul, the farmer who lived down slope of the planting, has observed that in years when Tagasaste was not planted the driveway to his house was subject to heavy waterlogging. However, since the Tagasaste has been established the lane way has remained dry. It only took two years for the Tagasaste to have an impact on the driveway once planted (SSC, 2001).

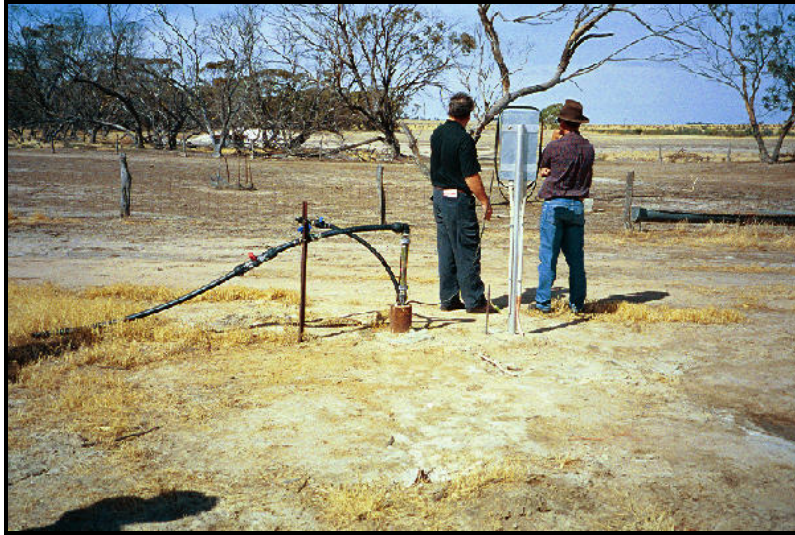
Figure 11 Groundwater pumping on Geoff Hocking's farm.

Discharge management includes tree planting, draining and groundwater pumping. Trees have been planted along creek lines and in low lying areas to reduce the groundwater levels and stop discharge. Drains have been constructed to increase the efficiency of high volume water flow down the creeks. Groundwater pumping is also used to lower the water table. The water from the bores on Geoff Hocking's farm is pumped two km away into a stream (Figure 11). This has been allowed because the groundwater is less saline than the water in the stream. The area where Geoff Hocking's groundwater pumps have been placed are around his house and machinery sheds. The salinity of this area is extreme with salt pans developing and threatening infrastructure. The pumps are holding the water table at bay, but other management options are needed to protect his land.

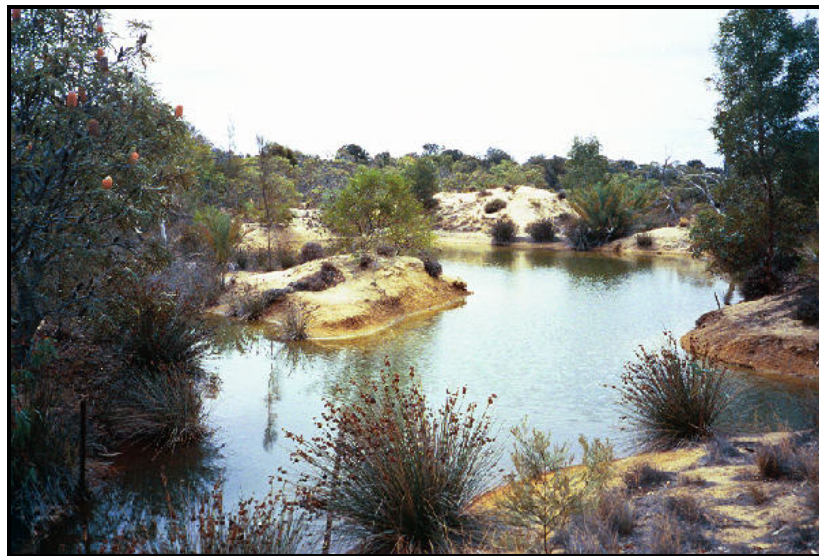
Figure 12 One of Derrick and Fay Chatfield's dams used for commercial fish production.

Derrick and Fay Chatfield's discharge management option has been to pump groundwater to lower the water table. The water is pumped into a series of dams where Cod, Yellow Belly and Silver Perch are grown for market (Figure 12).

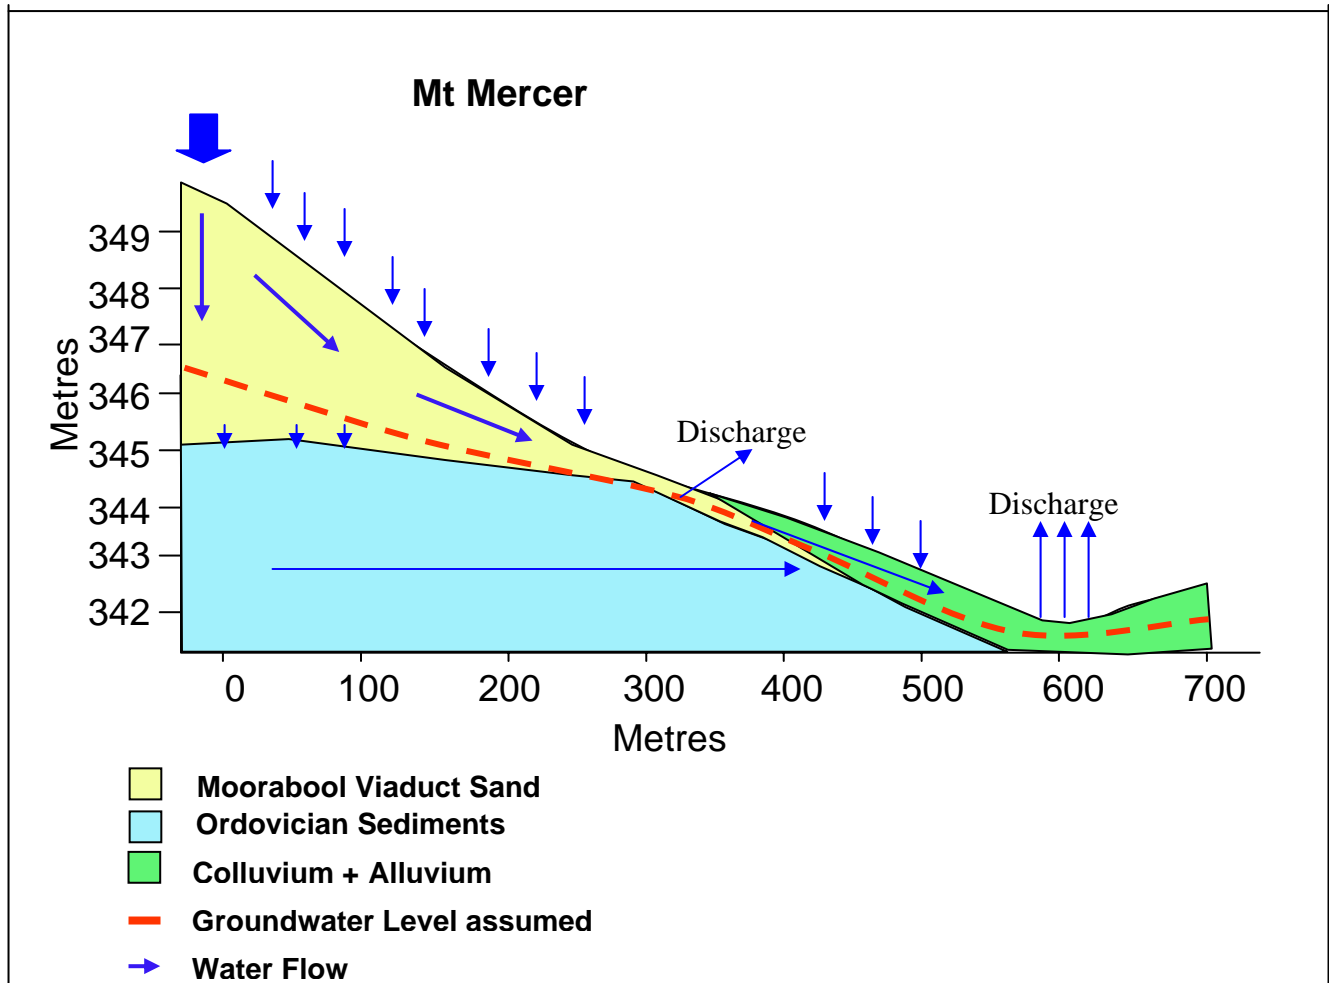
Figure 20 Hydrogeological cross section of the Mt Mercer site (Exaggerated by 37)

Moorabool Viaduct Sand is an unconsolidated deposit overlying a highly compacted and deeply weathered Ordovician turbidite. Textbook values for hydraulic conductivity of unconsolidated sands are typically orders of magnitude greater than for a fractured rock aquifer of compacted Palaeozoic sediments (Fetter, 2003). Therefore it is logical to assume that the Moorabool Viaduct Sand will be recharged faster and water will be

transmitted through the Moorabool Viaduct Sand at rates which are much greater (orders of magnitude) than the Palaeozoic. These facts lead to the development of a conceptual model as shown in Figure 20. The infiltrated rainwater moves vertically through the Moorabool Viaduct Sand, but cannot percolate into the Palaeozoic rock at the same rate, therefore the recharge is diverted laterally down the slope of the terrain and discharges where the Moorabool Viaduct Sand wedges out and in the valley floor.

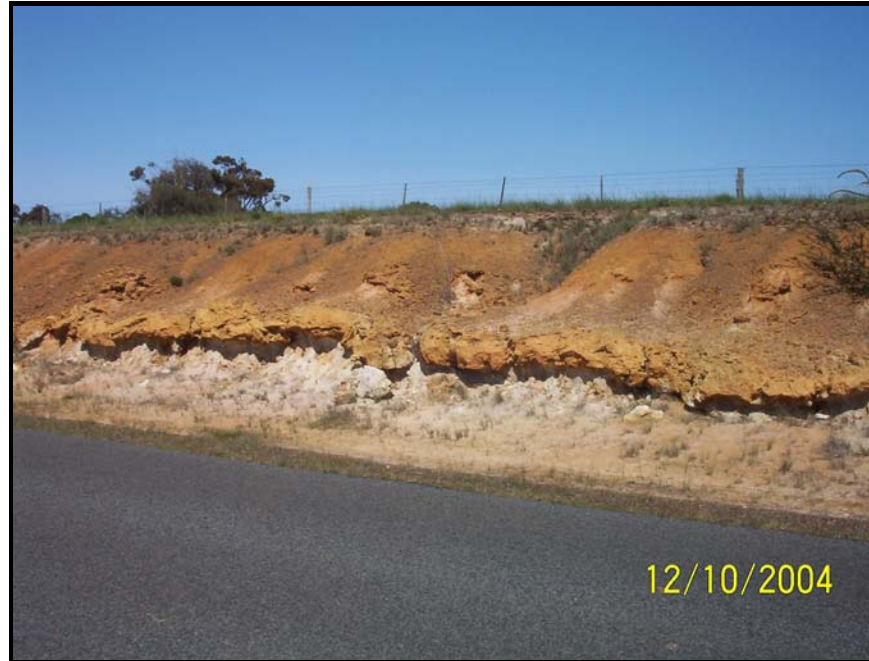
Figure 22 Road cutting near the Illabarook site showing Pliocene sands on top of Ordovician sediments

Figure 22 shows Moorabool Viaduct Sand overlying Ordovician (Palaeozoic) compacted sediments, which is situated in a road cutting west of the Illabarook site. As the Moorabool Viaduct Sand has a higher hydraulic conductivity than the compacted Palaeozoic sediments rainwater percolates down through the Moorabool Viaduct Sand reasonably quick and hits the highly compacted Palaeozoic sediments, which inhibits water flowing vertically. Water then pools and flows laterally on top of the Palaeozoic sediments creating a perched aquifer, which discharges at the side of the hills where Moorabool Viaduct Sand wedges out (Figure 23). The deep lead at the Illabarook site is also causing discharge at the base of the hill where it surfaces. The deep lead obtains water from both the groundwater table in the Ordovician sediments and through mine shafts which have a very high hydraulic conductivity and create easy paths for recharge into the deep lead (Figure 23).

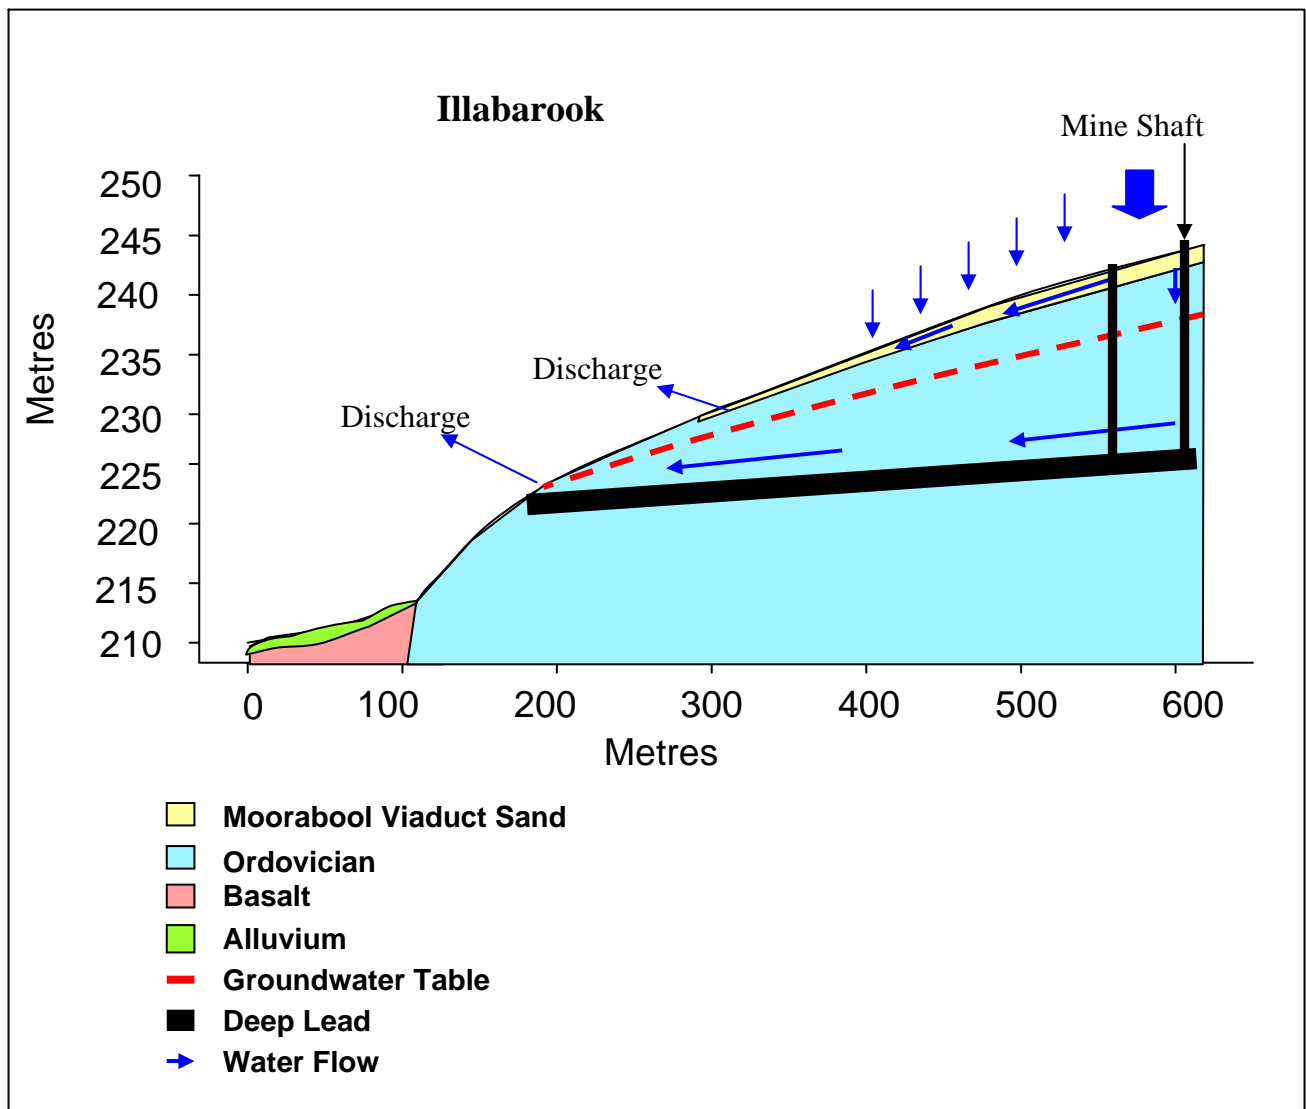
Figure 23 Hydrogeological cross section of the Illabarook site (Exaggerated By 7)

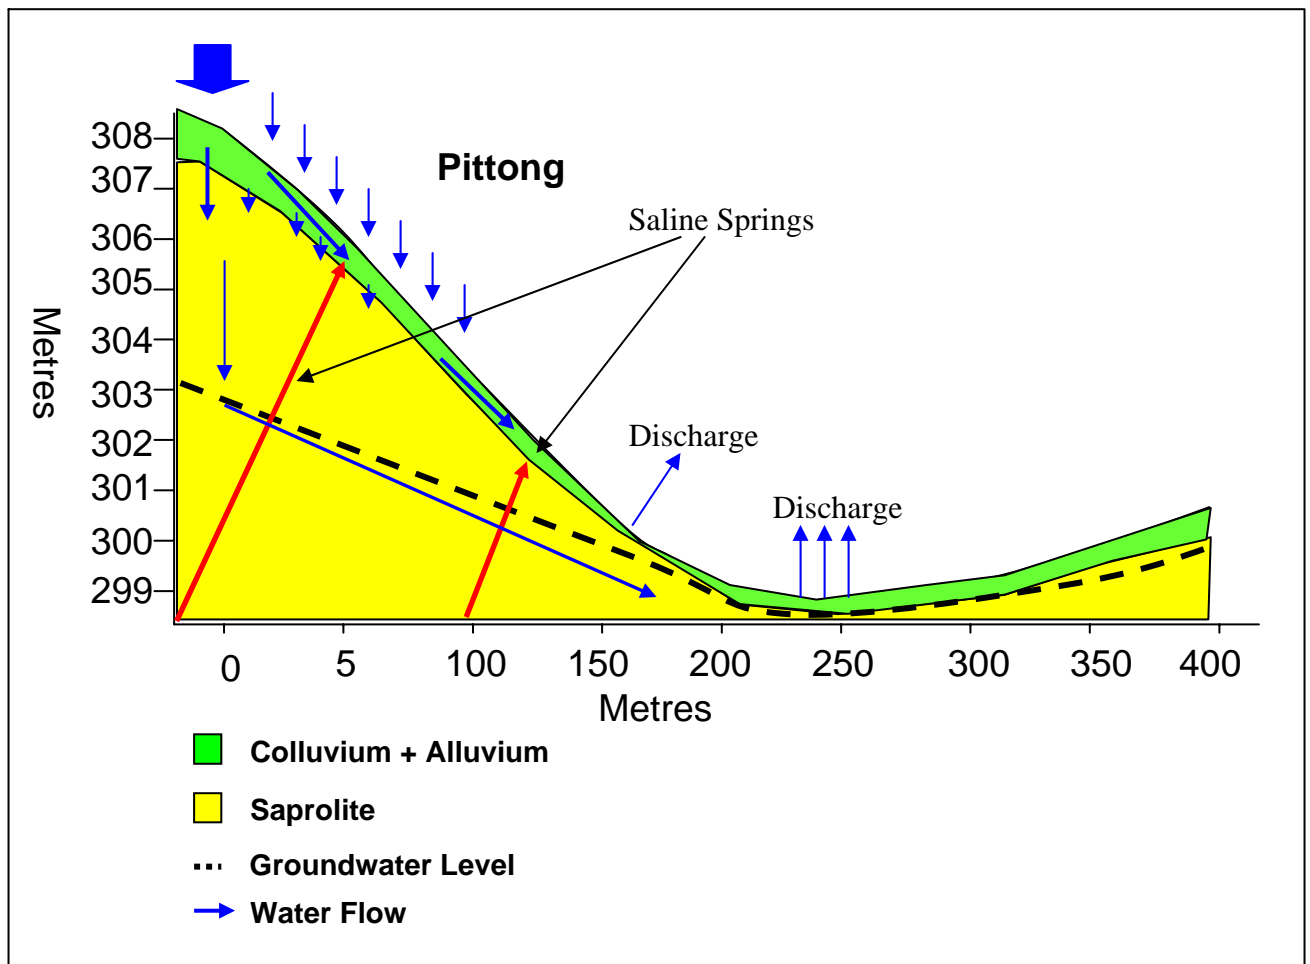
Figure 24 Hydrogeological cross section of the Pittong site (Exaggerated By 20)

Pittong consists of weathered granite (saprolite). Saprolite is a highly weathered (chemical) igneous or metamorphic rock which is very clay-rich and still possesses the structure of the unweathered rocks. Saprolite generally has a low hydraulic conductivity due to its a high clay content. Erosion has caused sandy colluvium and alluvium to develop on the sides of low undulating hills and in round valleys, as the weathered igneous rock contains quartz which has been weathered and mixed in with clay. As colluvium and alluvium have a higher hydraulic conductivity than the saprolite, rainwater

infiltrates the colluvium and alluvium at a higher rate than the saprolite is able to withstand, and water flows laterally and discharges at the base of the hill (Figure 24). As the water flows laterally it comes into contact with deep percolating water discharging from saline springs. The saline springs develop by high pressured deep percolating water navigating its way through joints of the now highly weathered igneous rock. A small proportion of rainwater infiltrates through the colluvium and alluvium and enters the saprolite raising the water table making valley floors waterlogged.

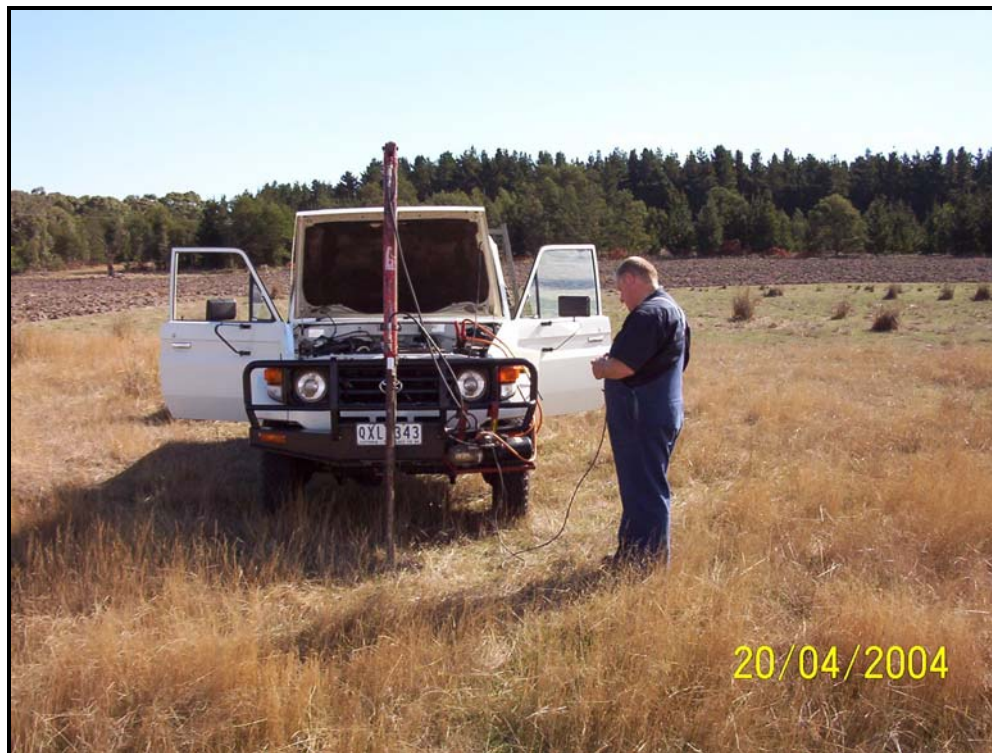
Figure 25 Soil coring at Mt Mercer

A soil survey was undertaken at each site to identify the soil profile and soil salinity. A powered hydraulic corer was used to extract 50-80 centimetre cores (Figure 25). The soil cores were transported back to the laboratory with minimum disturbance, where they could be manipulated and analysed (Figure 26). A GPS was used to locate soil cores and measure out distances between core samples. Core samples were taken around every 20 by 20 meters along a straight line through the saline areas and into less affected areas. This was done to show differences in salinity and soil texture throughout the site.

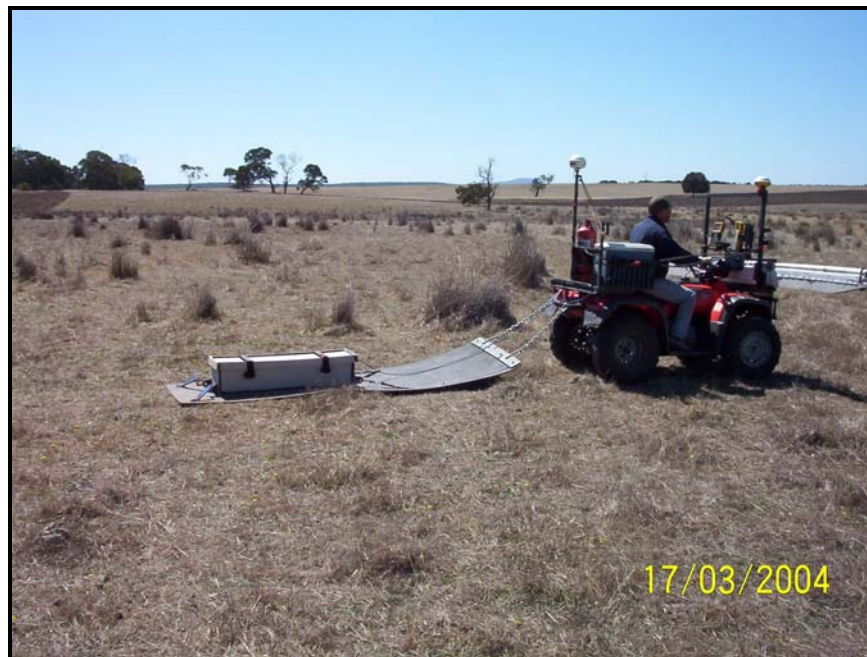
Figure 27 EM38 Survey

An EM38 and EM31 survey was carried out by Advanced Soil Mapping Deniliquin. A Geonics EM 38 (Trailing) and Geonics EM 31 (Mounted on front) were mounted on an all terrain vehicle and the survey was completed (Figure 27). An EM 38 and EM 31 produce a magnetic field inducing a current which flows through the soil. Because the magnetic field is of constant intensity the induced currents strength will only change as a result of varying conductivity of the soil, therefore giving an apparent electrical conductivity of the soil (Bates, 2004). Appended is the operational guide for using an EM38 (Appendix 2).

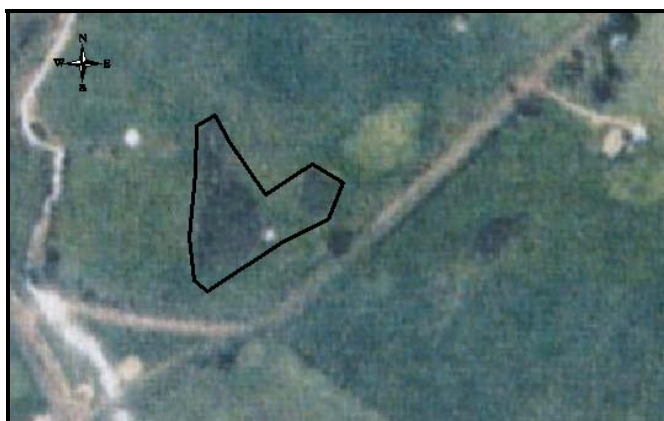
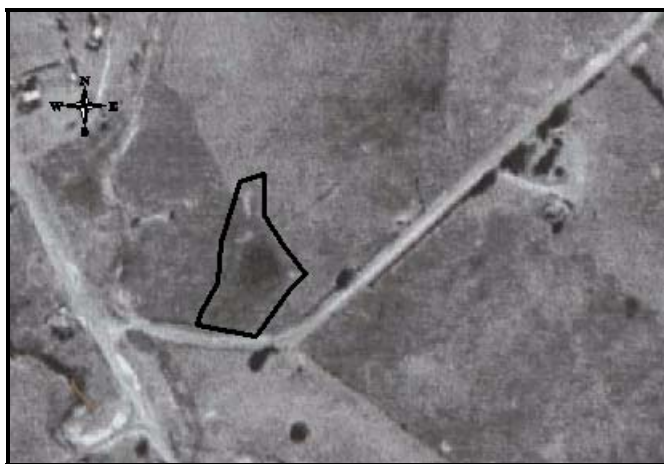
Figure 39 Historical air photography of Illabarook A) Illabarook 1990 B) Illabarook 1981 C) Illabarook 1970

Three historical aerial photos were selected to assess the severity of salinity at the site over the past 30 years (Figure 39). The photo history clearly shows that the area affected by salinity at the site has increased over 30 years. The estimated increase is 40 percent.

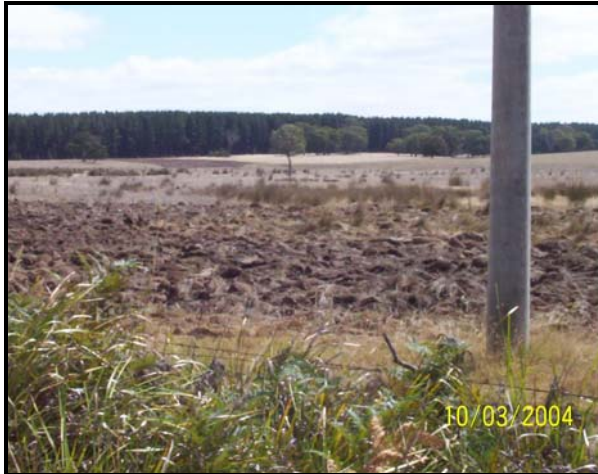
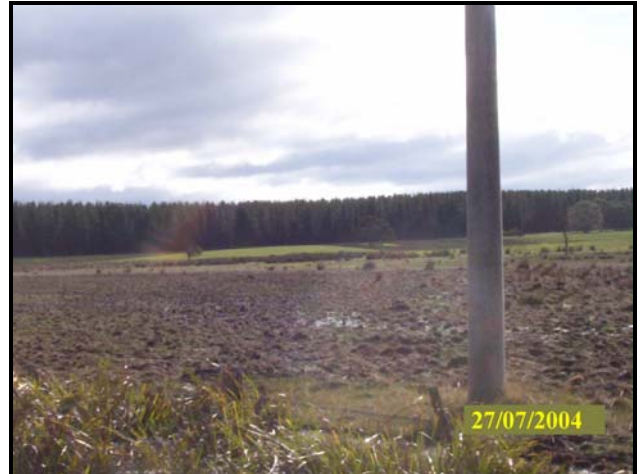
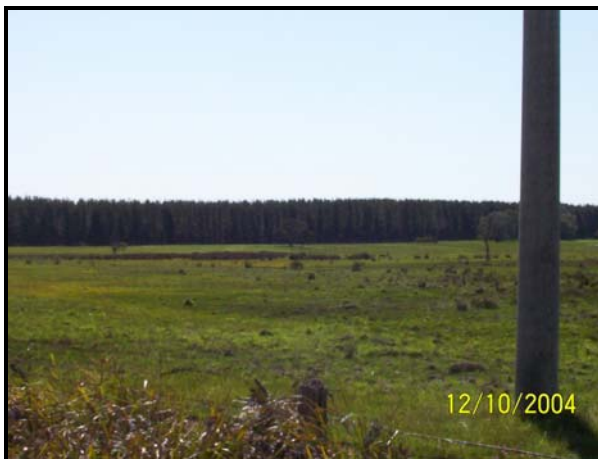
Figure 57 Mt Mercer photograph monitoring

As Figure 57 illustrates from Autumn to Spring there is a substantial change in vegetation growth and the visual state of the saline site. Appendix 23 obtains GPS locations and the direction the photographs were taken.

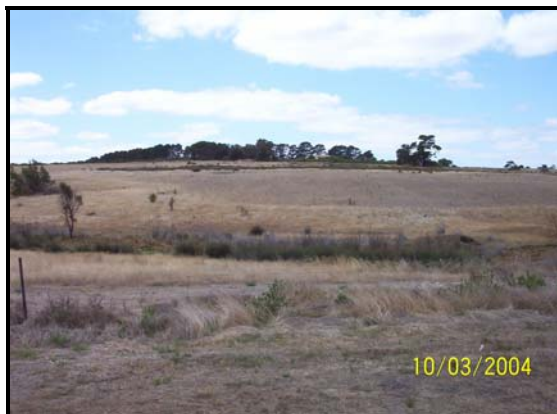
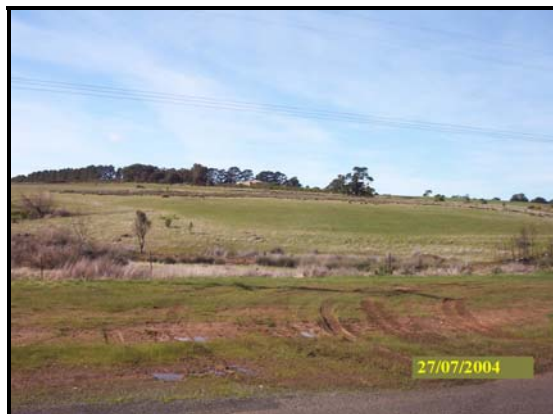
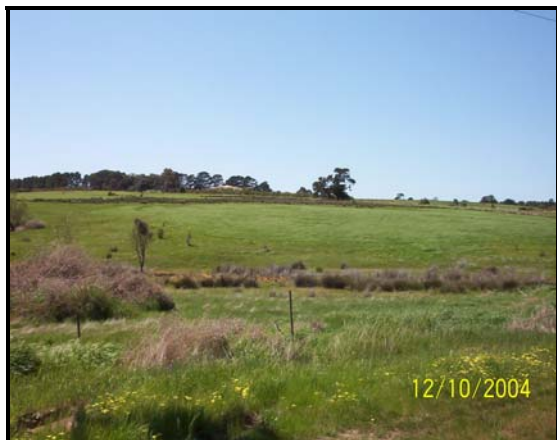
Figure 58 Illabarook photograph monitoring

As Figure 58 illustrates from Autumn to Spring there is a substantial change in vegetation growth and the visual state of the saline site. Appendix 23 obtains GPS locations and the direction the photographs were taken.

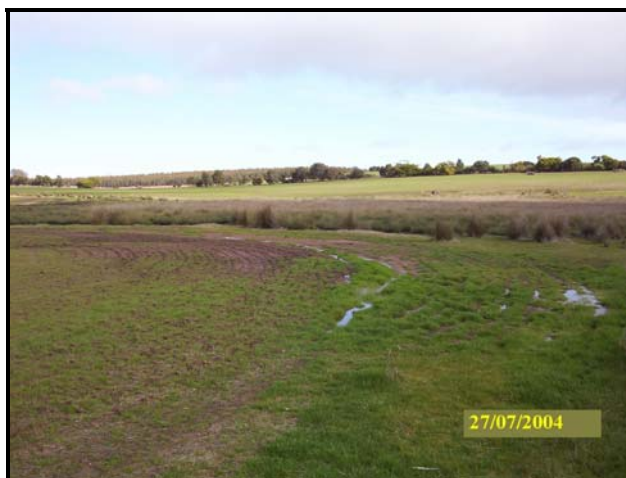
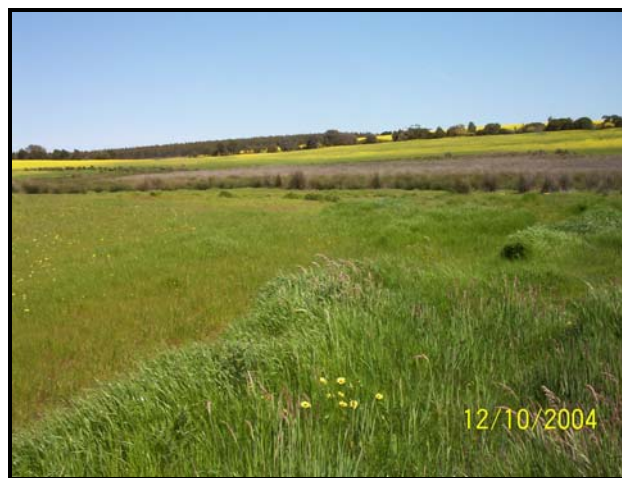
Figure 59 Pittong photograph monitoring

As Figure 59 illustrates from Winter to Spring there is a substantial change in vegetation growth and the visual state of the saline site. Appendix 23 obtains GPS locations and the direction the photographs were taken.
