# **ANGLESEA RIVER WATER QUALITY REVIEW**

**Independent Review by Professor William Maher**

**October 2011**

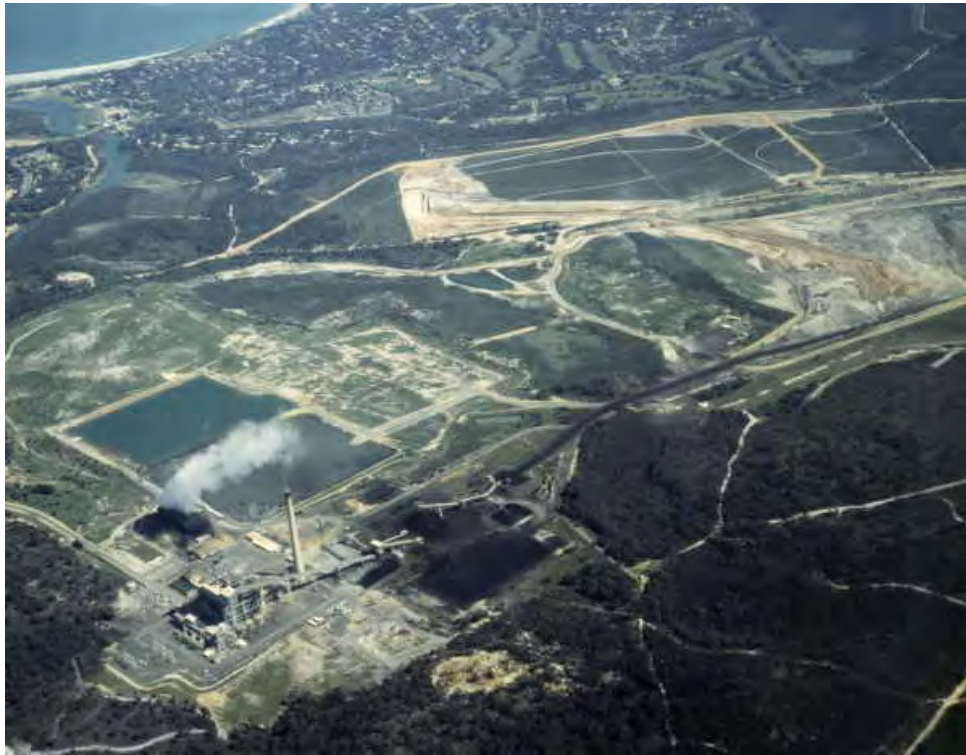
**Figure 2.** Aerial shot of the Anglesea township and estuary (top left corner) and Alcoa power station and coal mine. Two large water bodies are known as the ash ponds (Source; Wolfgang Seivers 1979 image from State Library Victoria).

An overhead view of the catchment is shown in Figure 2a and an aerial photo of the Anglesea township and power station (Figure 2b) shows the town and estuary located in the top of the image with the Alcoa power station and open cut coal mine across the middle of the image.

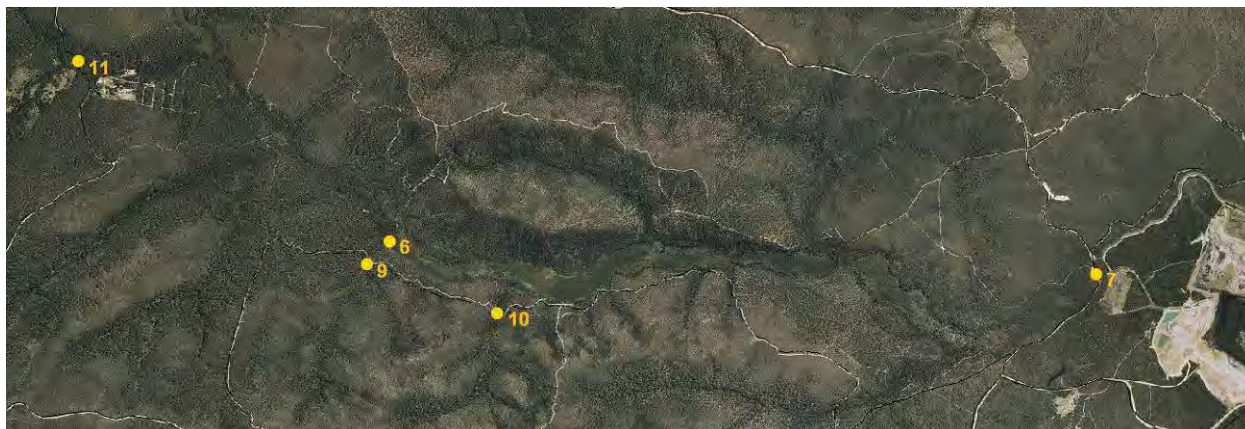
Figure 56. Image of Salt Creek showing sample locations.

Data from samples taken in the 2000 flood and fish death event show that the tributaries to Salt Creek on the high ground (Figures 56 - sites 9, 10 and 11) have low aluminium and sulphate concentrations (Table 1). Further downstream (Figure 56 - sites 6 and 7), the aluminium and sulphate concentrations in Salt Creek become much higher (Table 1).

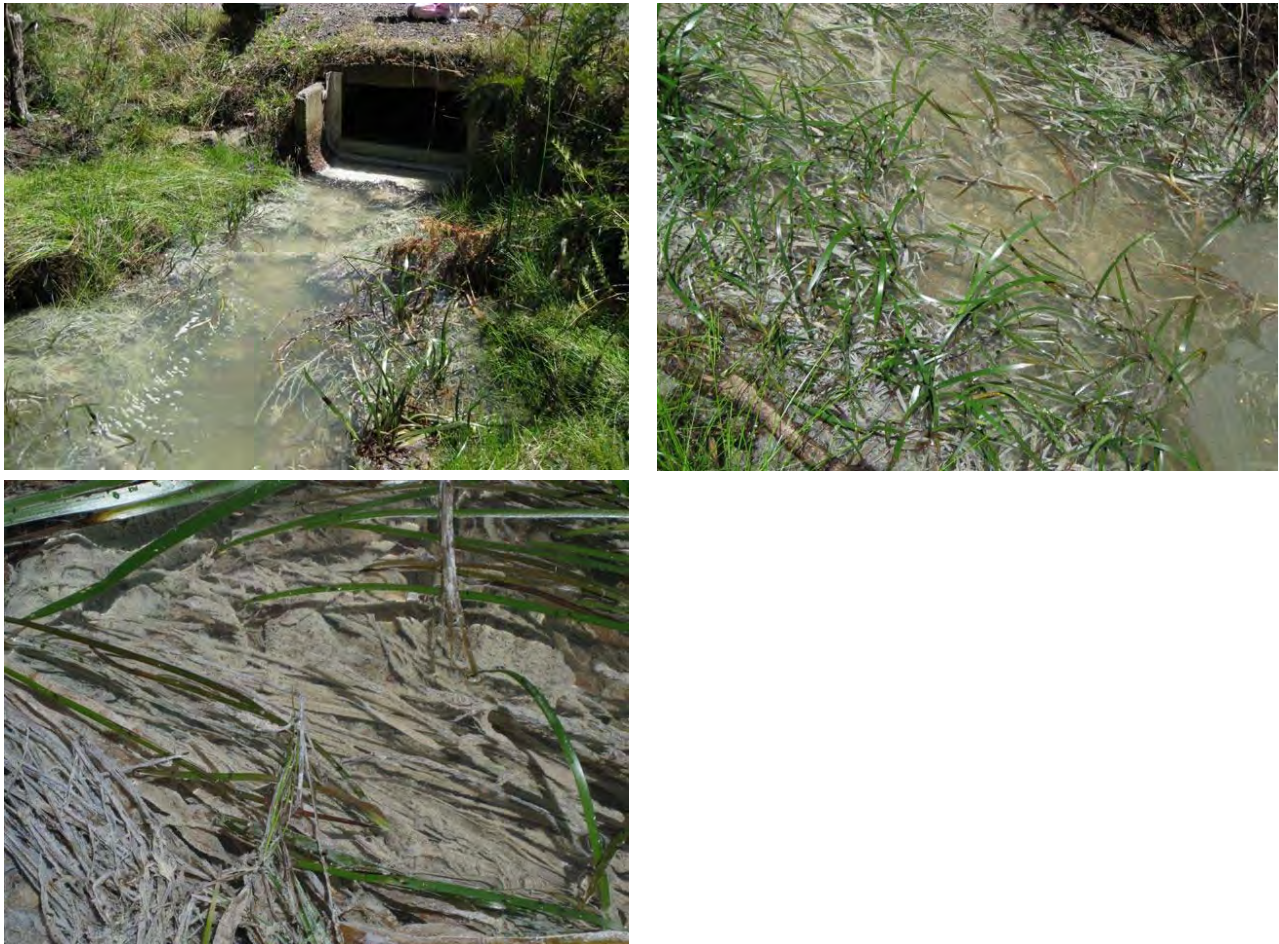
Parsons provided data to illustrate that the floccs contain large concentrations of a range of trace elements. Of note is the high concentrations of copper, chromium, iron, selenium, antimony and lead. He also provides data for trace element concentrations in fly ash and, using boron as a tracer, puts an argument that the origin of the flocculated material is from leaching of fly ash material. He has measured boron concentrations of 50 µg/l in Marshy Creek water, 60 µg/l in Salt Creek water and 1000 µg /l in the ash pond. Fly ash has 410 mg/kg of boron. Floc concentrations of boron were reported as mg/l, so no assessment of floc concentrations can be made.

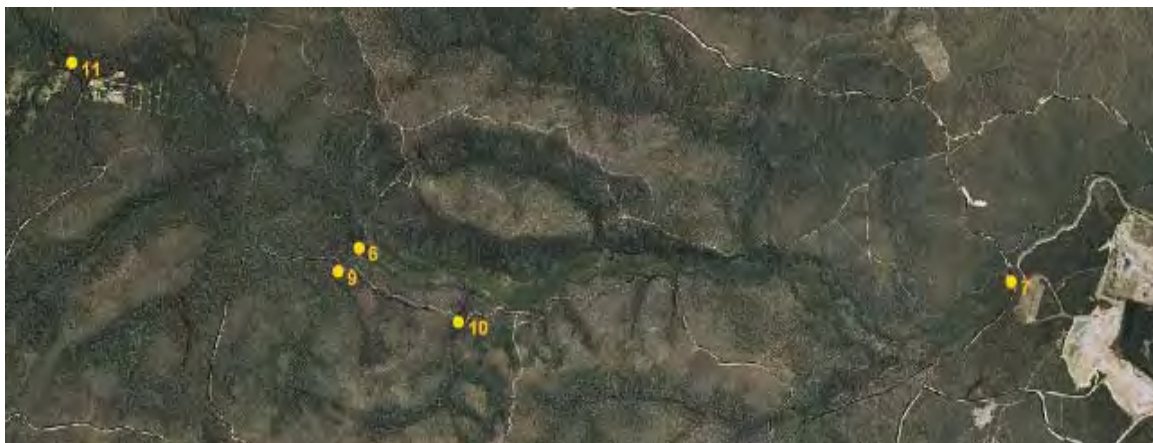
**Figure 68.** Location Site 6 (Denham Track on Salt Creek) of low pH, high aluminium and sulfate water quality results from testing in 2000. The old Roche mine is located adjacent to site 7 and the current operation is also evident by cleared land, approximately 4 to 5km downstream of site 6.

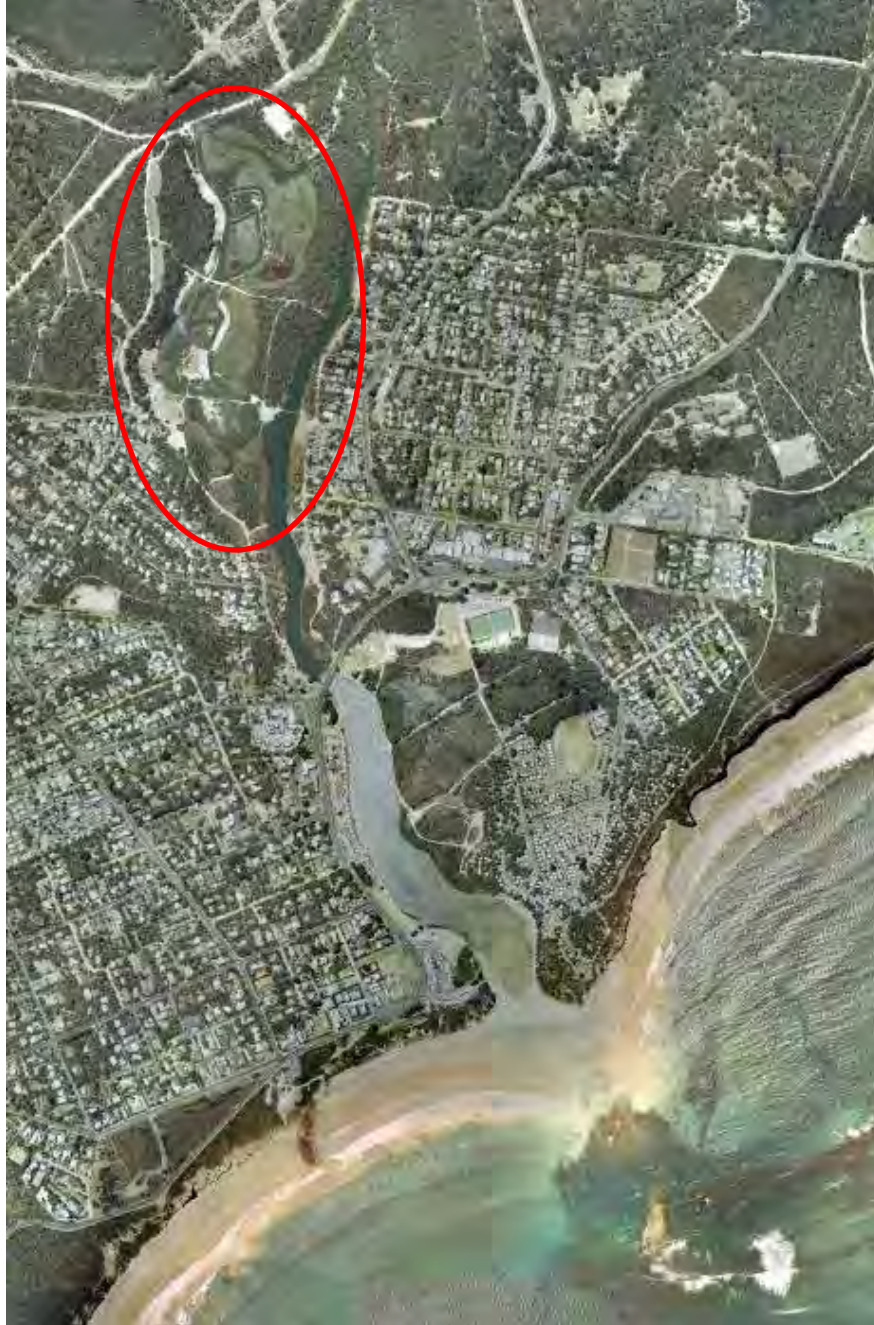
**Figure 81.** Anglesea estuary aerial photo – Coogoorah Park indicated by red oval (Source Anglesea EMP 2004).

Coogoorah Park (Figure 81) is described in the Anglesea estuary management plan as “a series of channels created to let water from the river extinguish peat fires post the 1983 Ash Wednesday bushfires” (Surf Coast Shire 2004).

Coogoorah Park is best described as a coastal peat swamp, and as such, has a similar process of acid generation as discussed in section 4.2.2.
