# Barwon Basin

## Water Quality

2021-2024

### How healthy is the water quality of the Barwon Basin?

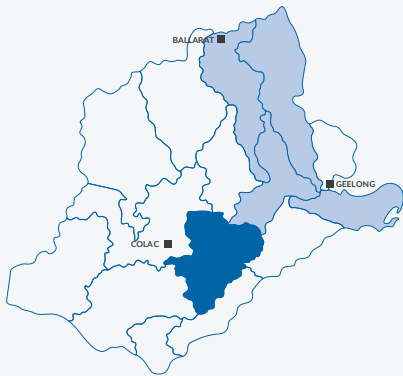
Due to the large number of sites assessed in the Barwon catchment the results are divided into sub-catchments according to the Corangamite CMA landscape zones. The five zones are Upper Barwon (11 WaterWatch sites), Mid-Barwon (3 WaterWatch sites), Yarrowee-Leigh (9 WaterWatch sites), Moorabool (10 WaterWatch sites plus 1 from Hovells catchment), and Bellarine (17 WaterWatch and 3 EstuaryWatch sites).

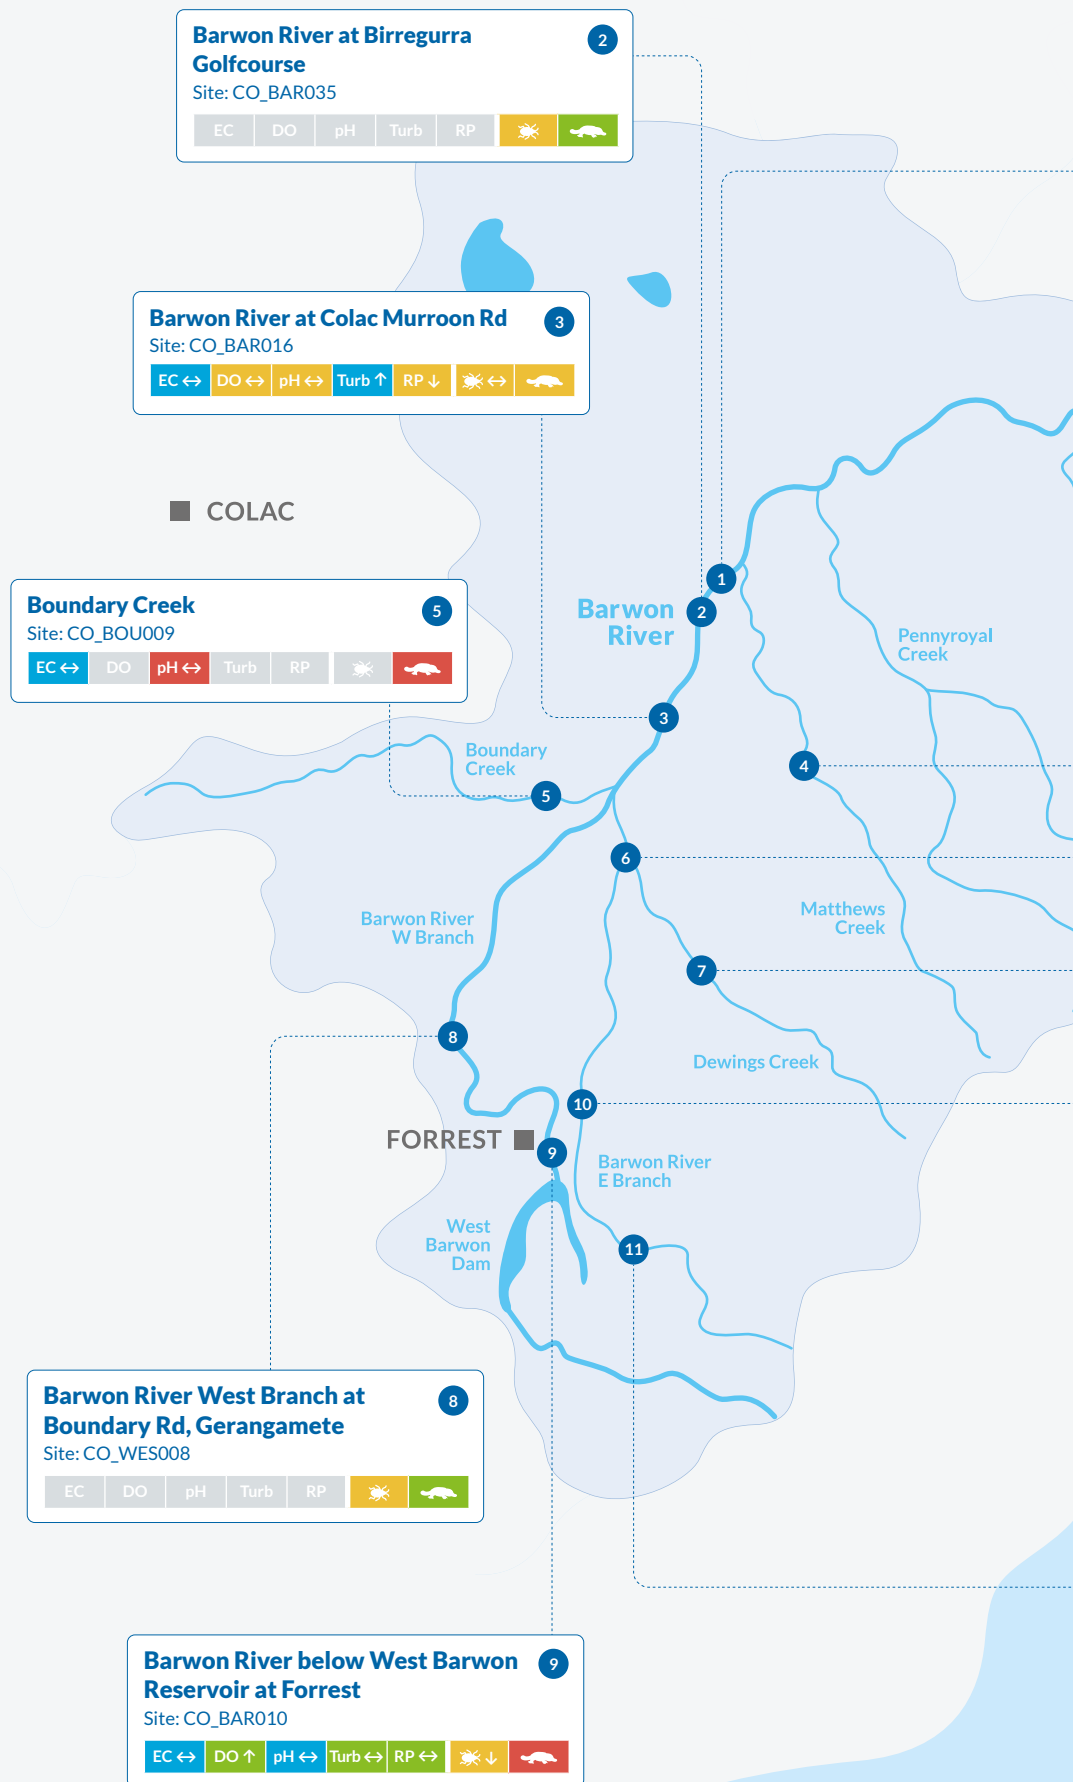
# Upper Barwon

As the Barwon River flows from the foothills of the upper catchment the water quality is very good, displaying low salinity, turbidity and nutrients such as phosphorus with healthy macroinvertebrate invertebrate surveys. Further down the catchment in the rural farmlands of the plains some decline in water quality are evident at several sites, this is further supported by the generally poor macroinvertebrate communities present at the sites surveyed. Changes in land use has greatly reduced native riparian vegetation and even complete removal of vegetation has happened in the past.

The water quality in the Barwon River varies as rainfall in the catchment transports sediments into the river, particularly from the small intermittent streams that flow from the Otway Ranges such as Mathews Creek. Increases in salinity also occur in these streams at times of no river flow and may be impacted by the ingress of saline ground water.

A notable increase in nutrients such as phosphorus is also evident and likely linked to farming practices and has the potential to increase the growth of aquatic plants and even stimulate algal blooms. This in effect alters the dissolved oxygen levels in the water. During daytime, as a product of photosynthesis, oxygen levels increase at times to supersaturation levels (> 110 % saturation). During the night when plants are not photosynthesising the dissolved oxygen levels can drop to extremely low levels.

Low pH levels had been recorded at Boundary Creek indicative of acid sulphate soils in the catchment. Boundary Creek flows into the Barwon River it is likely to have an impact on the receiving waters.

River systems are dynamic and respond to change. To make long term positive change, on ground works including weed removal and river bank revegetation has occurred in reaches of the East and West branches. The delivery of water for the environment to deliver baseflow during low flow periods (summer-autumn) freshens water quality improving waterbug habitat accessibility. Eight sites in the Upper Barwon have been monitored in spring and autumn to help evaluate the benefits of water for the environment.

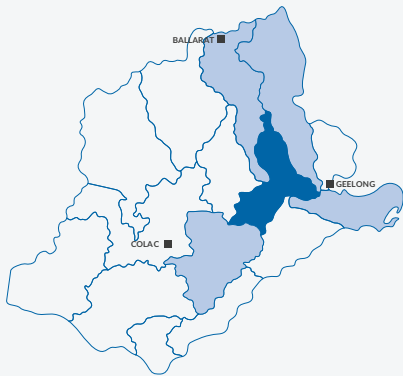
There is a limited amount of WaterWatch data for the mid Barwon. Disruption caused by the COVID-19 pandemic and resulting restrictions caused a stop to WaterWatch and EstuaryWatch programs in 2020. It has taken time to reestablish volunteer groups and recommence monitoring activities.

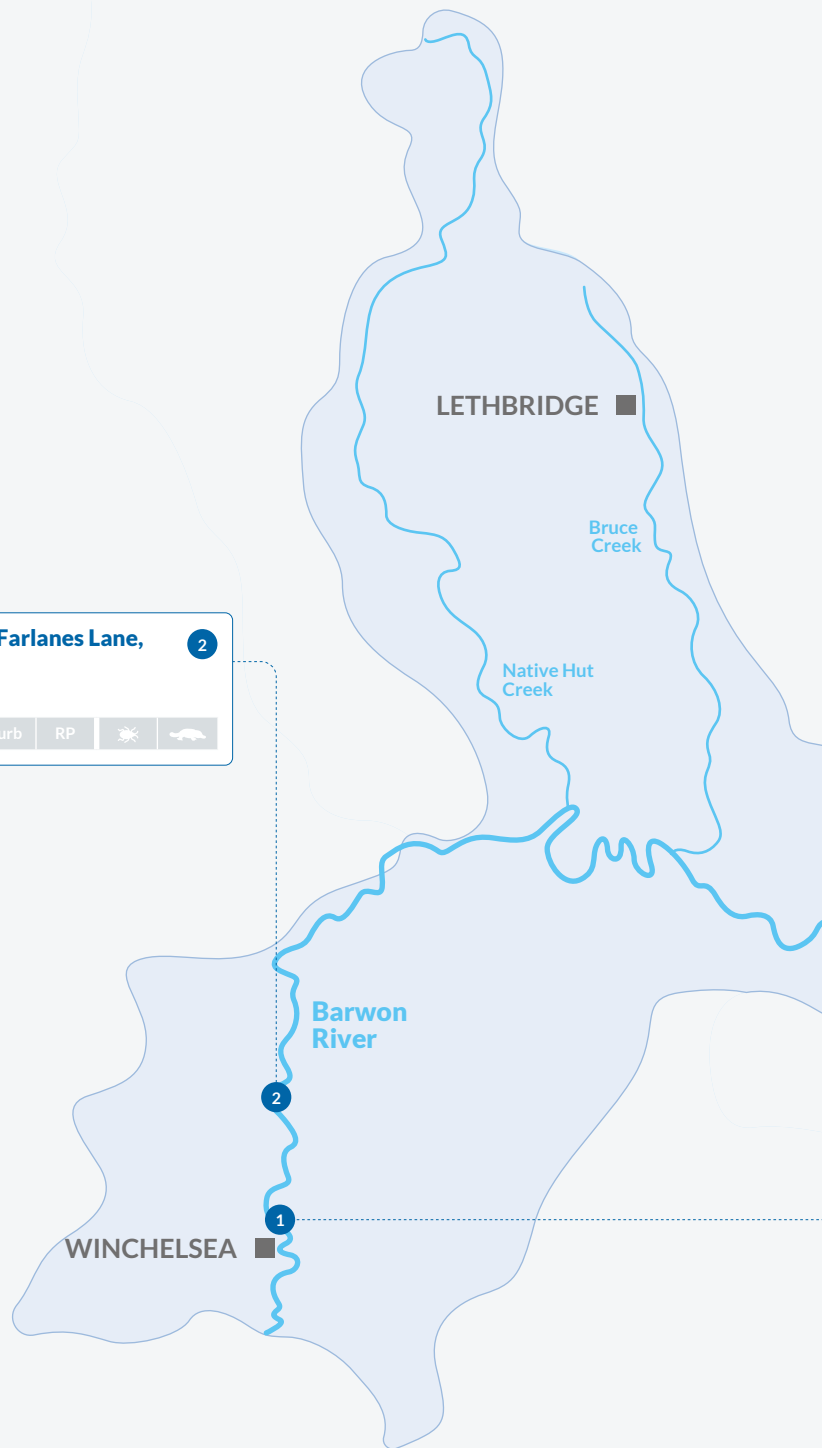
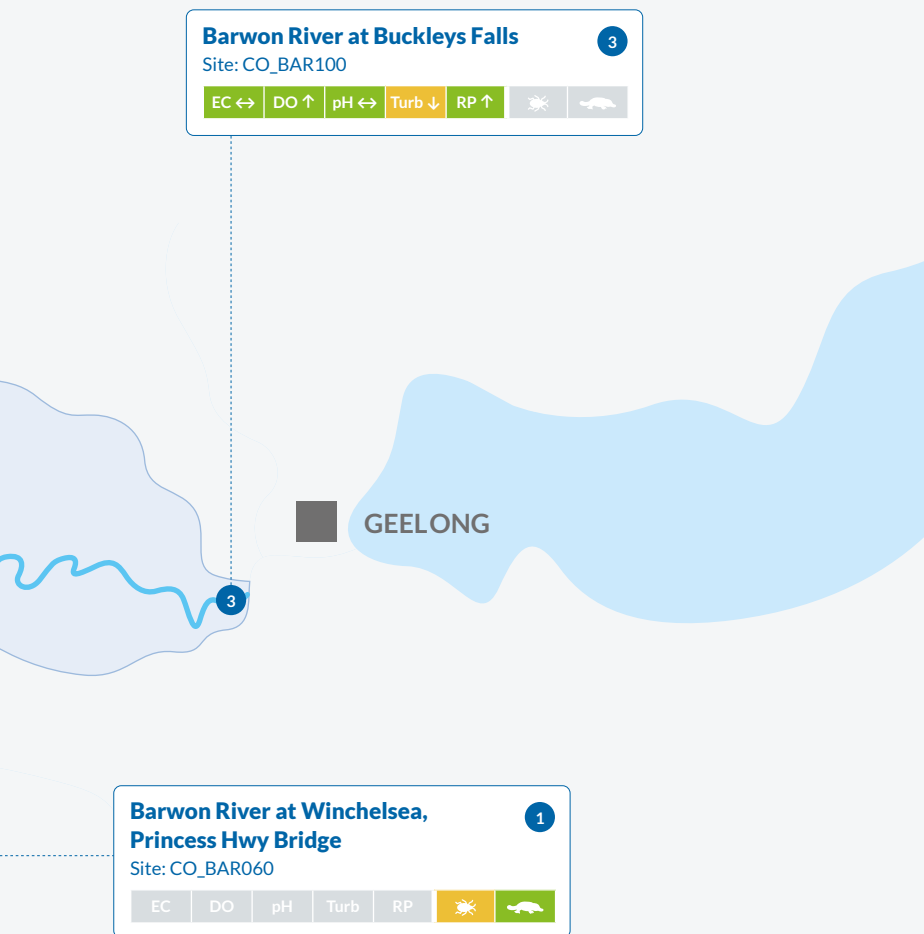
# Mid Barwon

The platypus eDNA survey conducted in the Upper Barwon extended to Winchelsea where a positive signal was measured. As the Barwon River flows from the upper catchment into the mid reaches from Winchelsea through the rural farmlands of the plains to Geelong decline in turbidity is evident.

Increases in salinity and phosphorus occur in a downstream direction and can be partially attributed to inflow from the Leigh River. As the Barwon River enters the city of Geelong the water quality is reasonably healthy for a lowland river with turbidity the only parameter in a poorer state than in 2020.

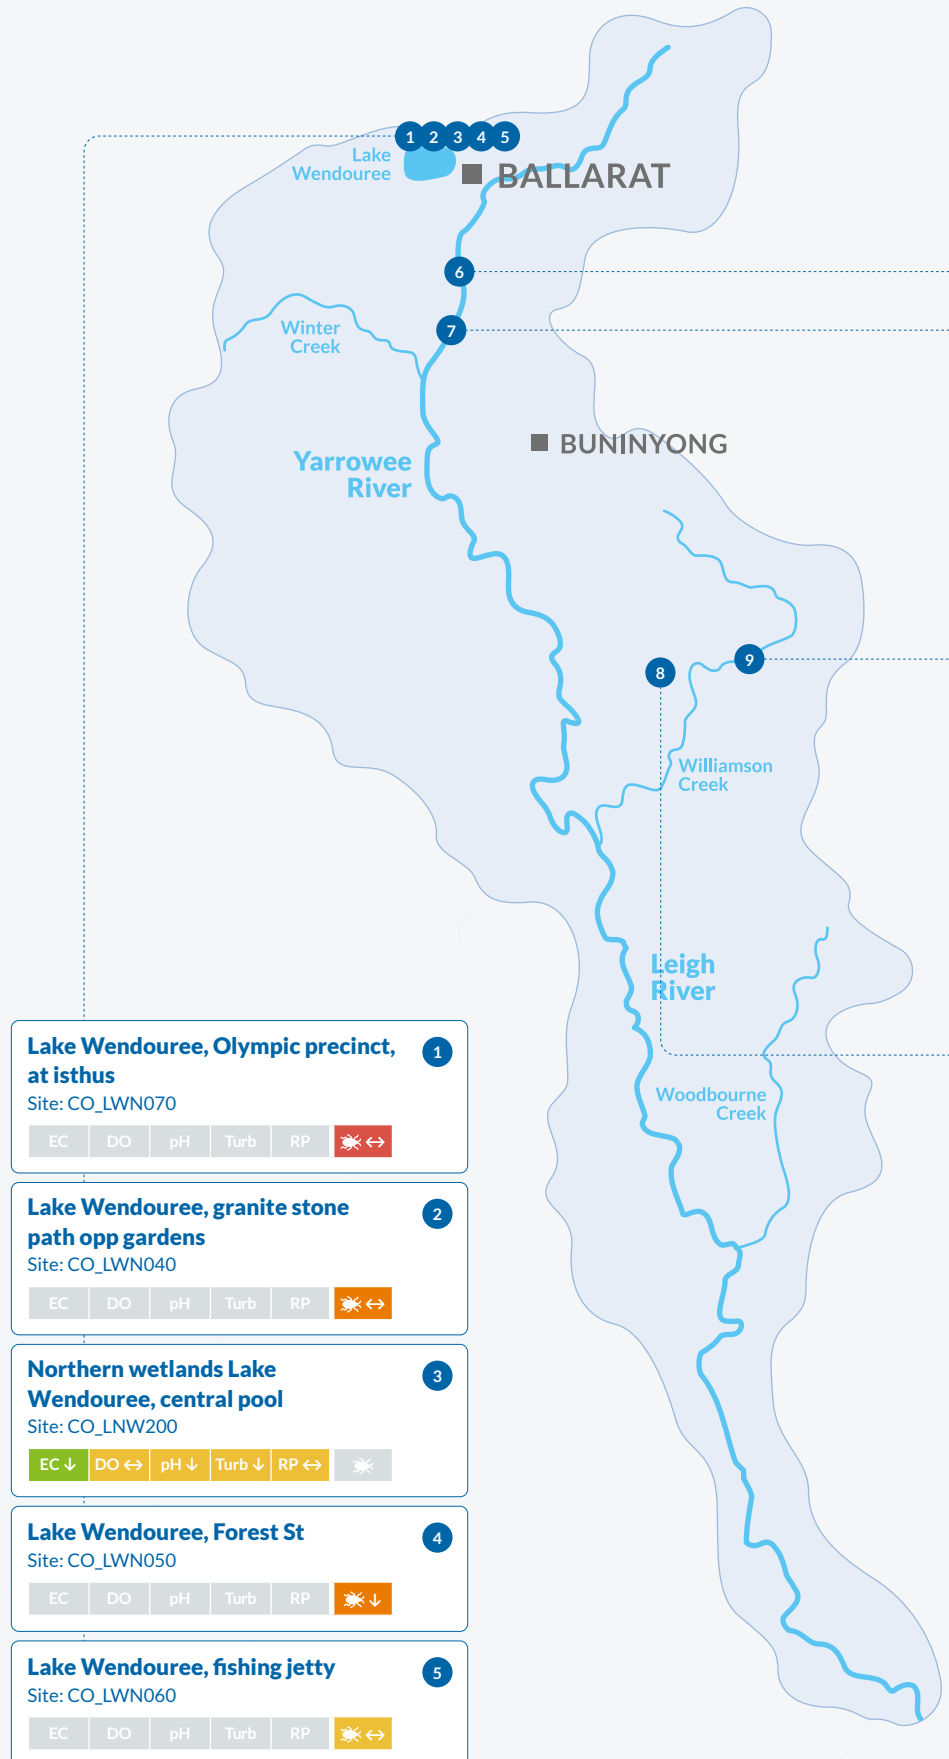
# Leigh

Lake Wendouree is an urban constructed lake in the regional town of Ballarat that receives stormwater runoff from sources including the Northern wetlands. The Northern wetland has healthy salinity levels but the turbidity, pH, phosphorus and oxygen levels are in poorer condition because of stormwater input. The macroinvertebrate community of Lake Wendouree is mildly to heavily impacted. There was consistency with waterbug scores from the 2020 report for 3 out of 4 sampling sites around the perimeter of the waterbody indicating waterway health is mostly unchanged.

Yarrowee River was monitored at 2 sites downstream of Ballarat city centre. Salinity and pH at site CO\_YAR094 was healthy, however there was low dissolved oxygen, high phosphorus and turbidity. In addition, aquatic macroinvertebrates at the site were heavily impacted. The water quality of site CO\_YAR100 downstream of Ballarat's waste water treatment plant was healthy, however phosphorus levels were high. High phosphorus levels can stimulate excessive aquatic plant and algal growth.

The rainfall 2021-2024 in the Yarrowee Leigh catchment has been higher than average contributing to greater flow which has improved water quality. Williamsons Creek, a tributary of the Leigh River displayed relatively healthy water quality, and this is an improvement on reported water quality in 2020. This stream met most of the ERS water quality objectives however had elevated turbidity and phosphorus levels. The macroinvertebrate community indicate the site to be heavily impacted.

A wetland in the Williamson Creek sub catchment near Narmbool showed mostly good condition however salinity and dissolved oxygen were in poorer condition.

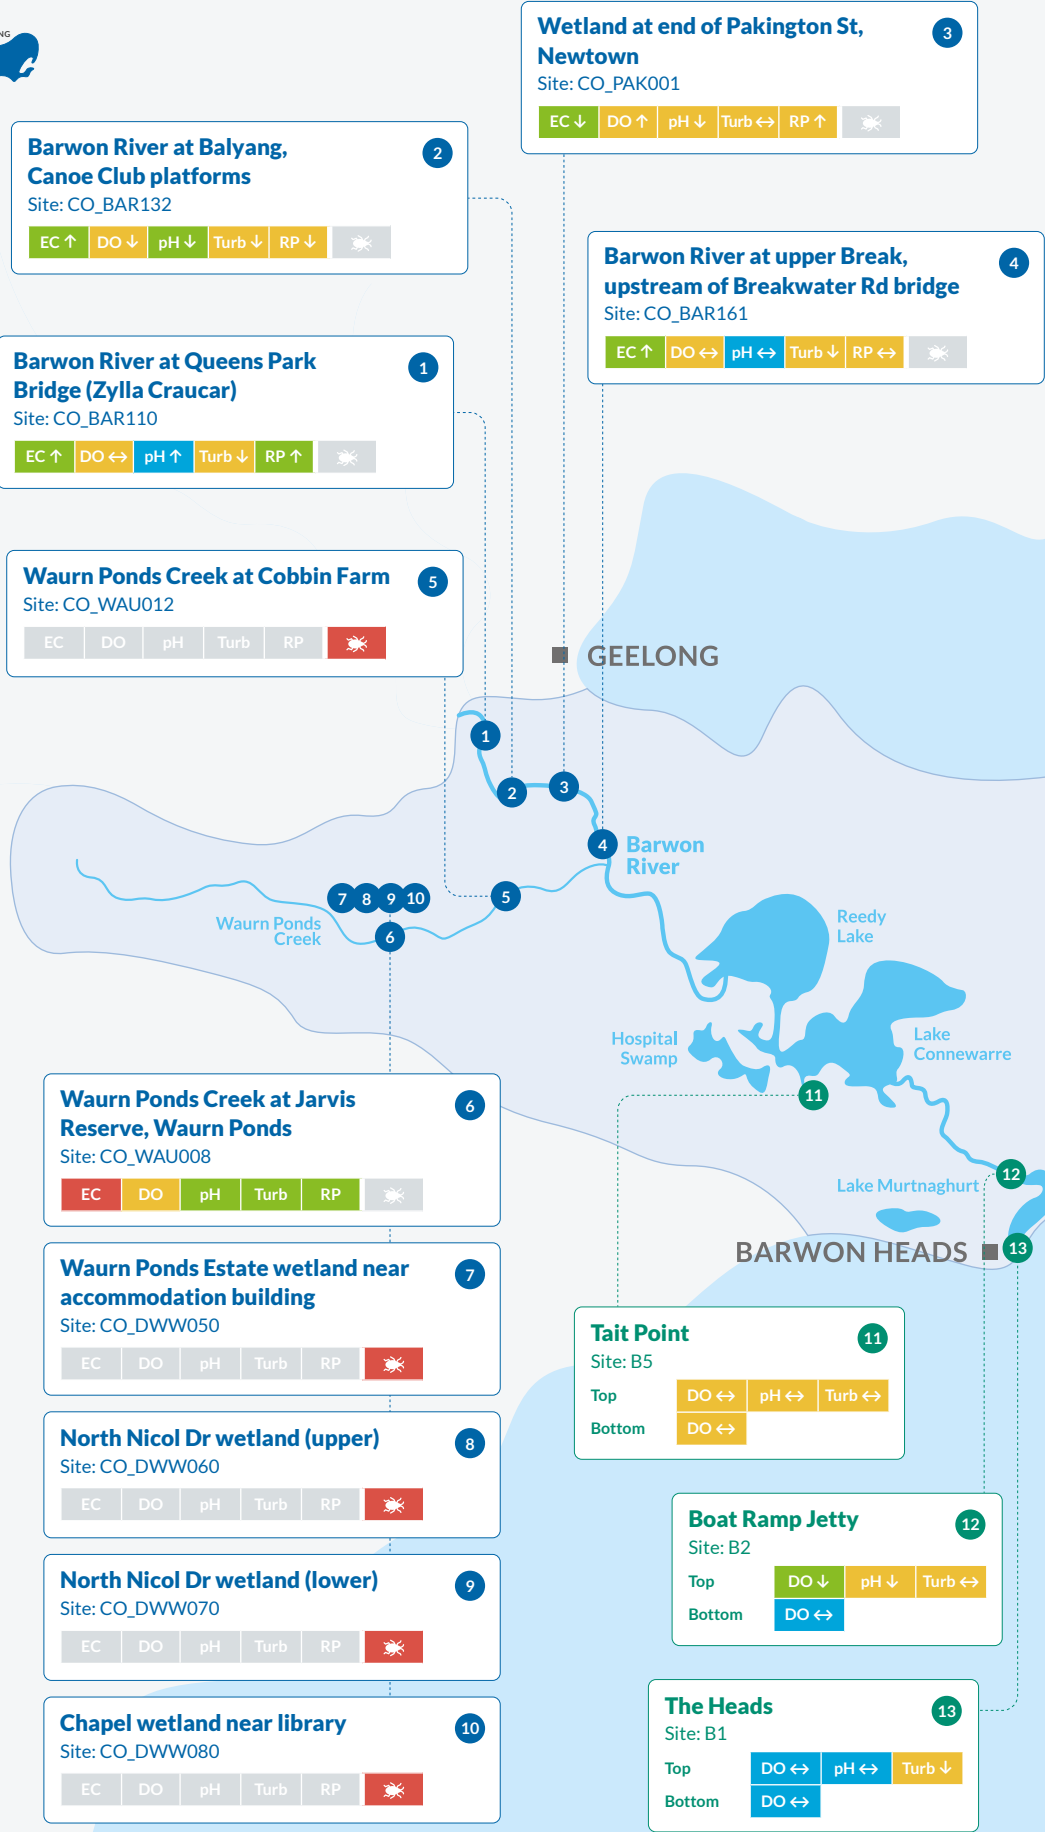
# Bellarine

As the Barwon River makes its way through Geelong below the confluence with the Moorabool River the water quality is marginally degraded. The water is more turbid as a result of sediment transport and condition has declined since 2020. The wetlands on the banks of the Barwon River receive urban stormwater runoff. High phosphorus levels are common and may encourage macrophyte and algal growth which potentially creates oxygen troughs over the summer to autumn seasons and raises pH levels. A blue green algal bloom was observed by Barwon WaterWatch volunteers in 2024.

Waurm Ponds Creek, adjacent to Deakin University campus, displays poor salinity and oxygen levels. In the lower reaches it is stormwater fed and macroinvertebrates indicate the creek is heavily impacted. At Deakin University Waurm Ponds campus a series of recently constructed wetlands have been monitored by students who found the macroinvertebrate communities to be heavily impacted. Future surveys monitoring change will help inform management of the campus wetlands.

As the Barwon River enters the estuary at Lake Connewarre the water quality is marginal. During flood events flows in the catchment completely flush the estuary of saltwater and becomes freshwater dominated, high turbidity occurs at this time however is only short lived as the tidal salt wedge pushes back up the estuary. Over summer as river flow declines saltwater dominates with evidence of salt wedge development. There can be an increase in algal growth in the surface waters and on the bottom substrate, particularly in shallow Lake Connewarre. At times the bottom waters become super saturated with dissolved oxygen likely due to benthic algal mats photosynthesising. A blue green algal bloom was observed at B2 by Barwon EstuaryWatch volunteers in 2022.

As the river nears the estuary mouth to Bass Strait the water quality is very good although turbidity levels remain elevated. During seasonal high river flows the water represents that of freshwater for a brief period, most of the time the water representing that of seawater due to the strong tidal influence.

Freshwater wetlands at the top of the Swan Bay catchment are stormwater fed and have maintained marginal water quality. The saline wetlands at Point Lonsdale and Lake Victoria have also maintained marginal water quality, however have low phosphorus levels. With the exception of dissolved oxygen, the quality of the saline water circulating at The Point showed good condition.

Sampling sites at Clifton Springs are stormwater fed and showed high phosphorus levels. Their proximity to the bay has resulted in high salt levels in otherwise good quality water.
