# **ANGLESEA RIVER ACID FLUSH EVENT**

## **November 2025 – Part A**

**Artificial Estuary Opening and Environmental Impact.**

**Technical Report No: 137**

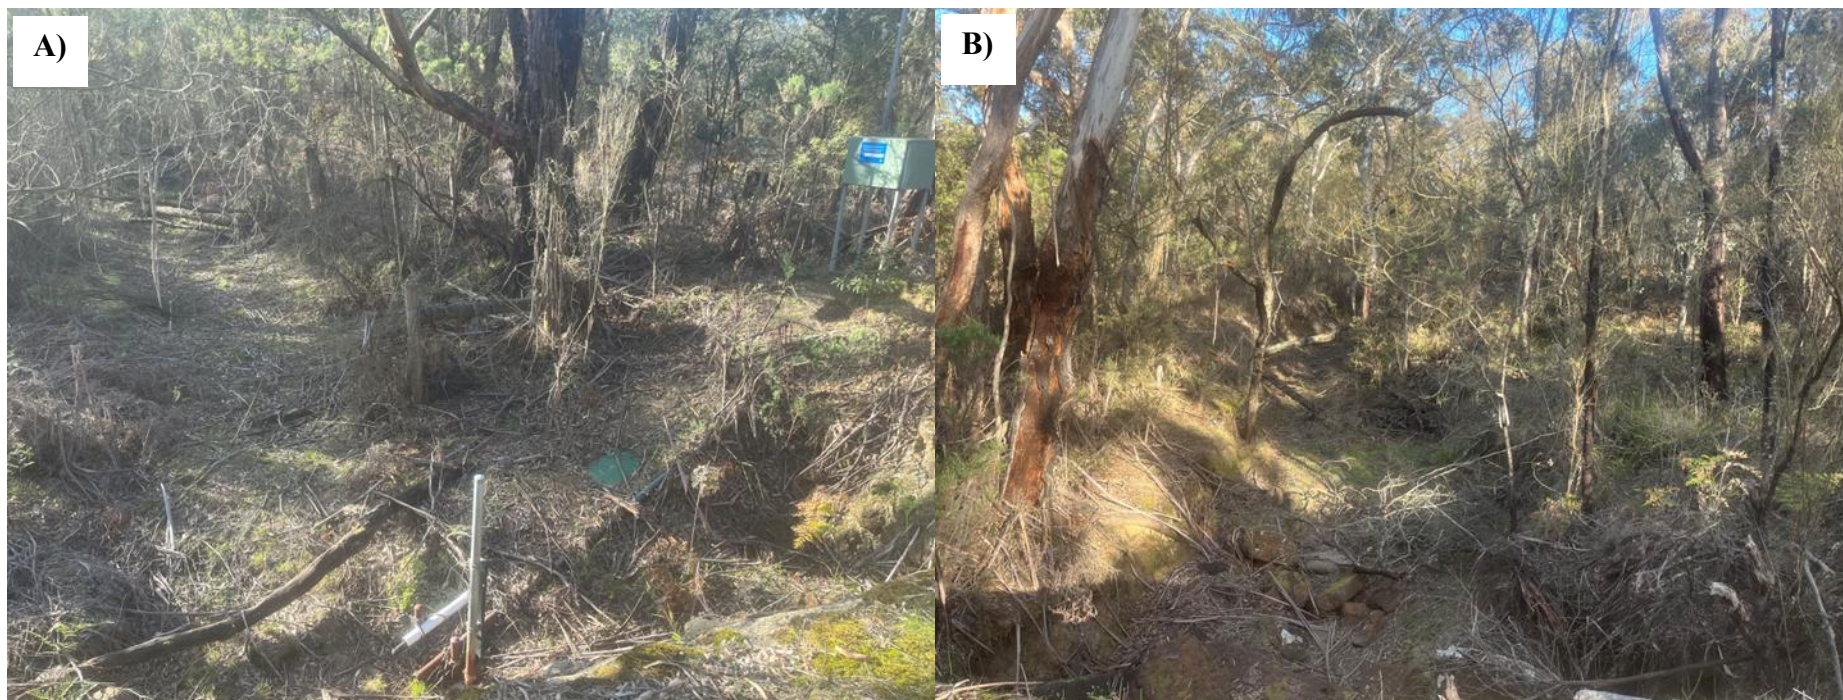
**Figure 2.** Images taken of the **Gum Flats Road** monitoring station on the Anglesea River upstream (A) and downstream (B) on 23 August 2025 during the opening of the estuary, this stream was found to be dried up with no water flow.

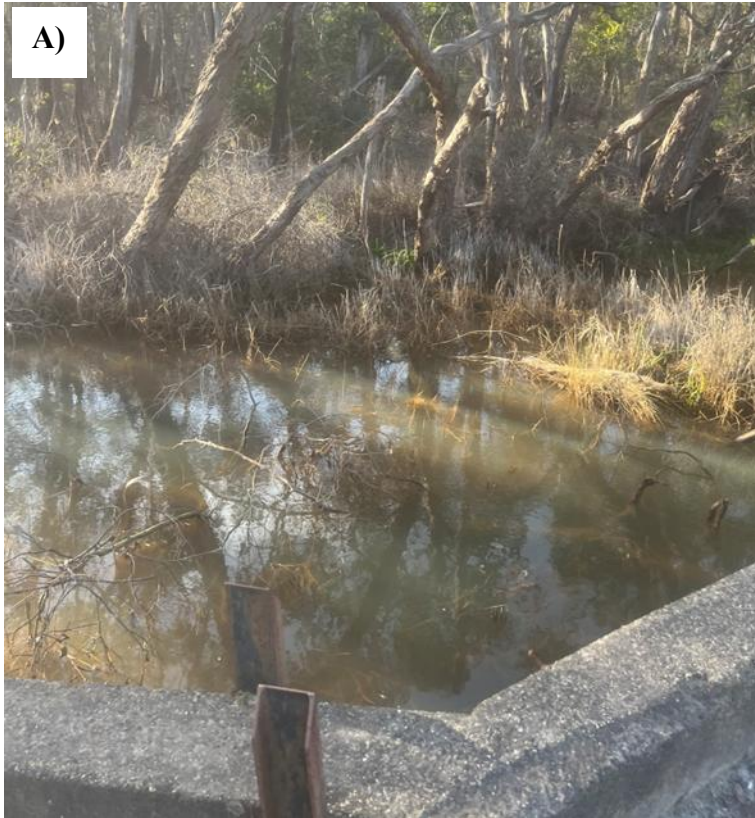
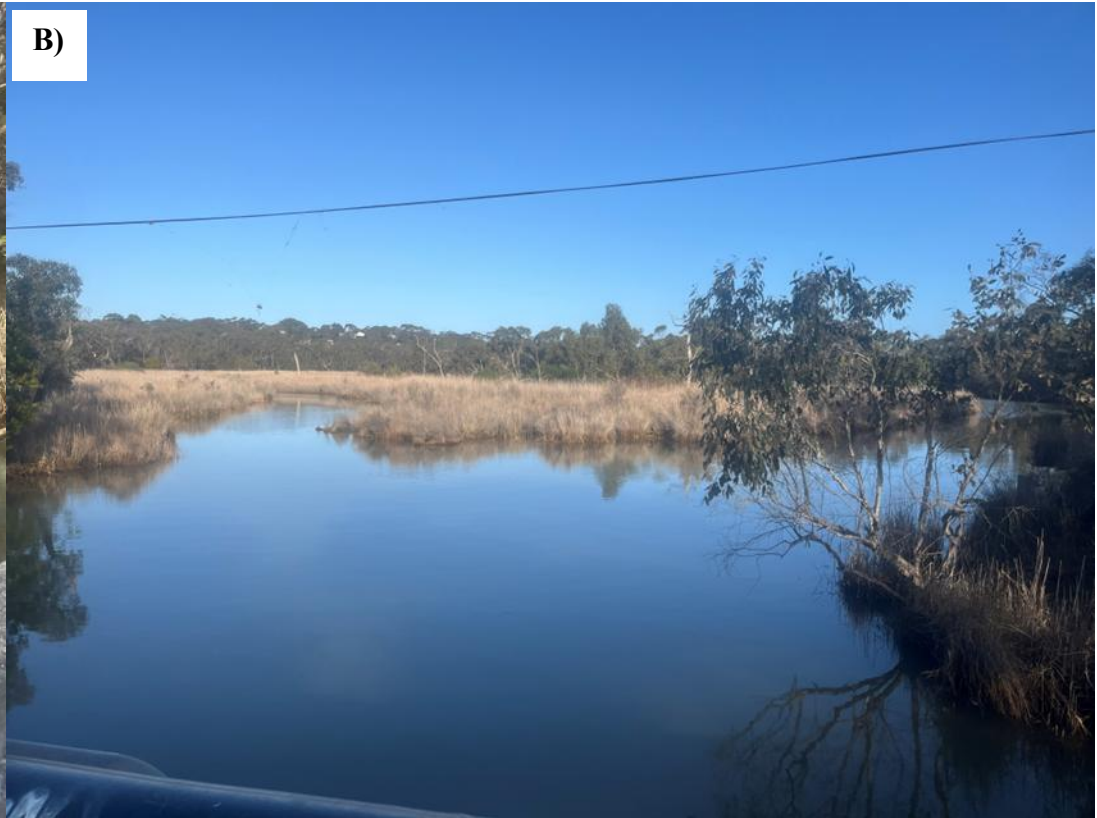
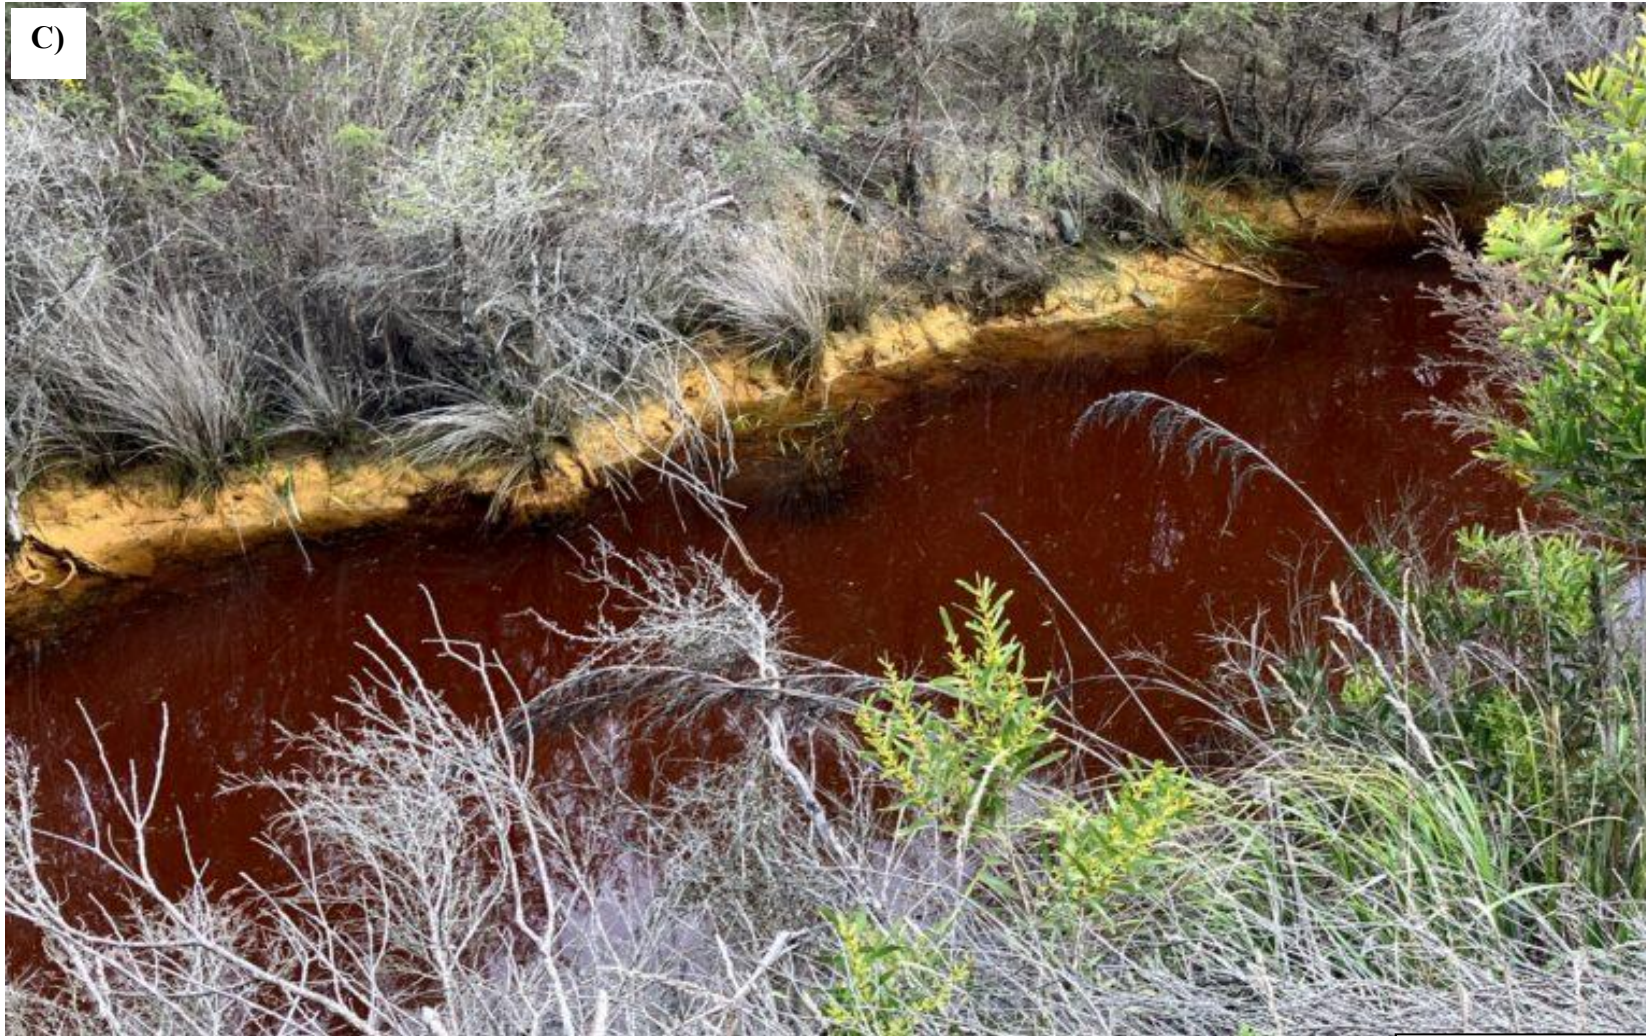
**Figure 3.** Images taken of upstream (A) and downstream (B) of Coalmine Road on 23 August 2025 during the opening of the estuary, and image C. the state of the Anglesea River about 70 metres upstream from Coalmine Road (Claringbold, E.,2025), demonstrating discolouration of the water, indicating high acidity event.

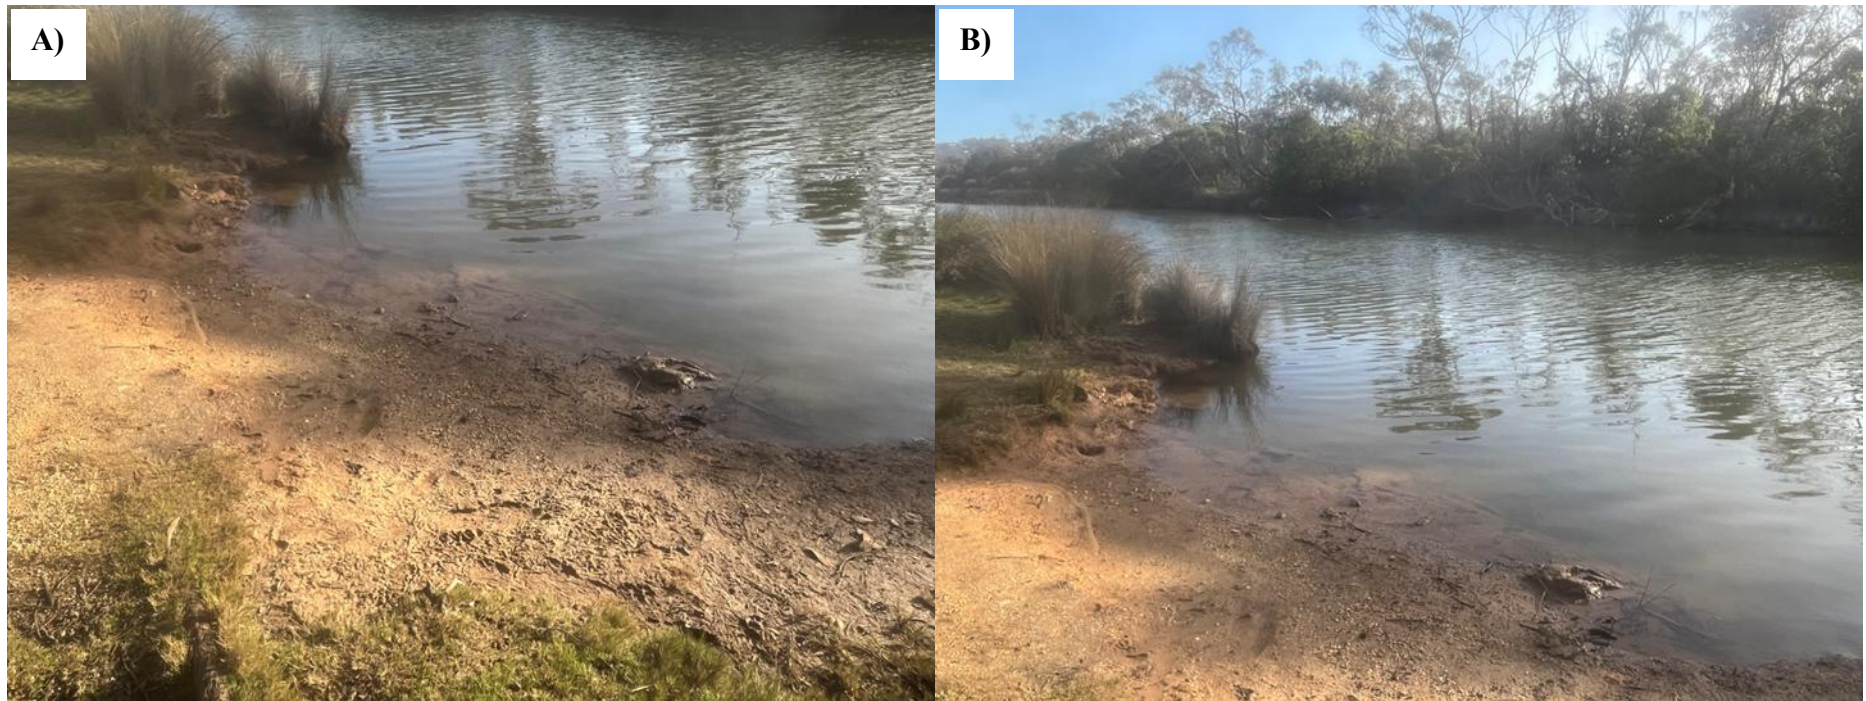
**Figure 4.** Images taken of the **Anglesea River on Agnes Road** (A) and (B) on 23 August 2025 during the opening of the estuary, showing reddish soil in the riverbank and discoloured water indicating low pH in the water.

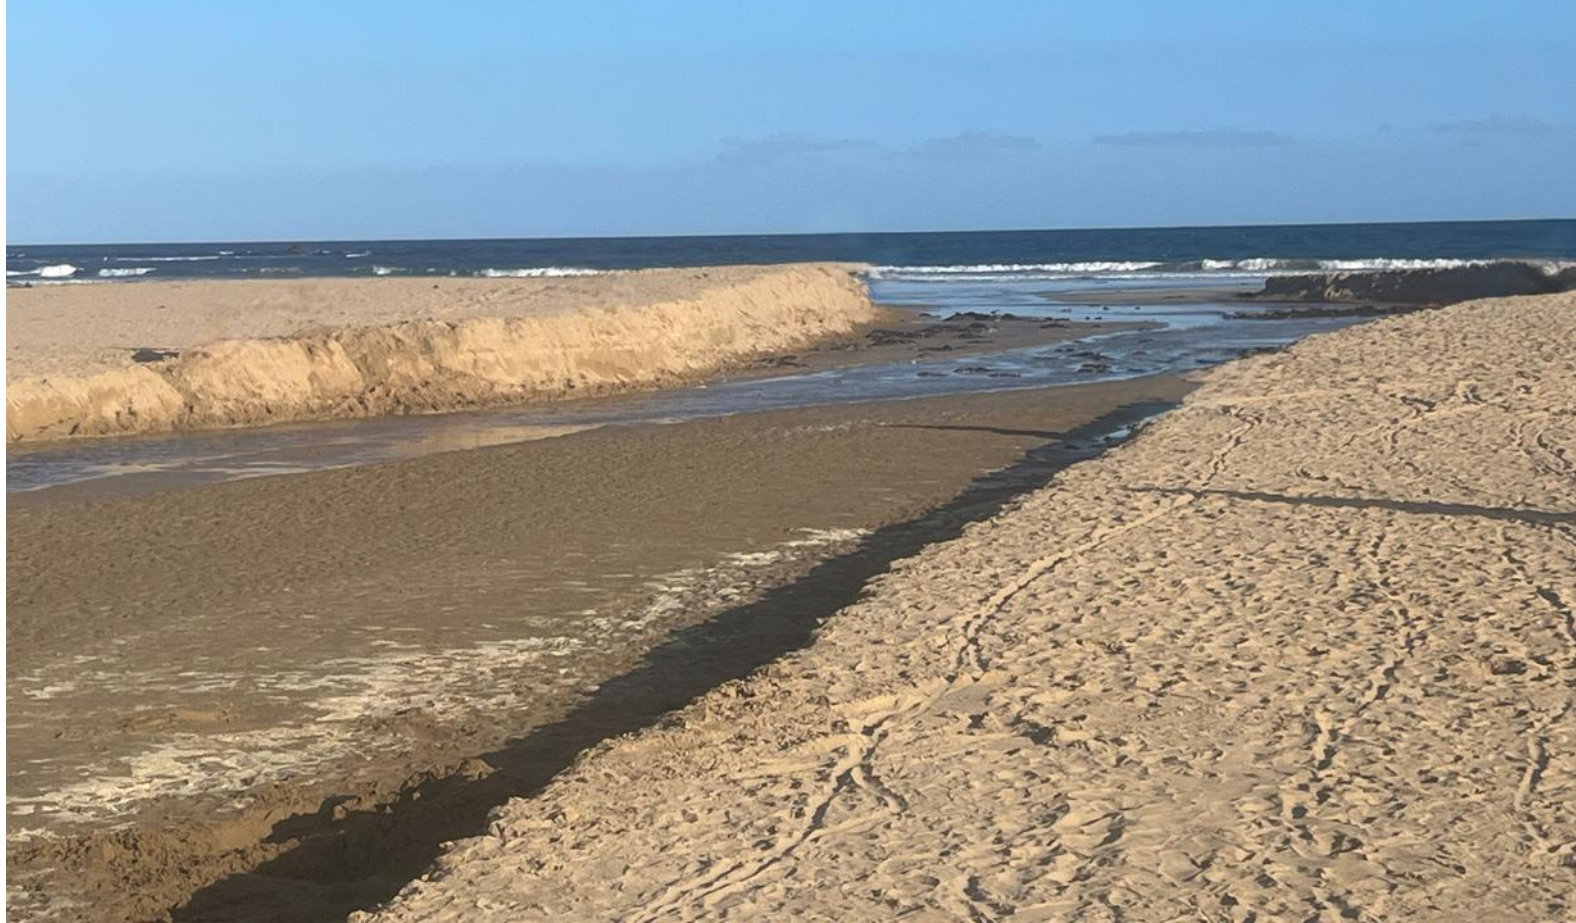
**Figure 6.** During an estuary opening, water from the estuary discharges into the ocean through the **Anglesea River estuary mouth**, and the image shows the shallow water flow. The image was taken on 23 August 2025 after the estuary was artificially opened.
