# Karaaf Wetlands

## Estuary Mouth Assessment

*Report for Corangamite Catchment Management Authority*

June 2023

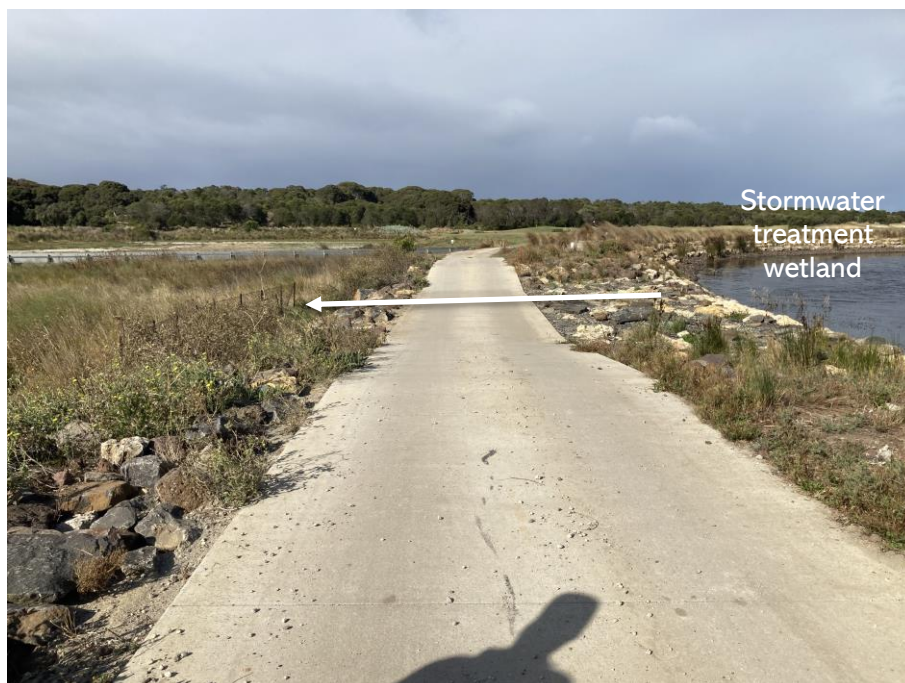
The stormwater enters the Karaaf wetlands after passing through several stormwater treatment ponds. The inflow to the wetland is via a low broad weir, Figure 4.

Figure 4 View of the overflow weir from the final stormwater wetland into the Karaaf Wetland

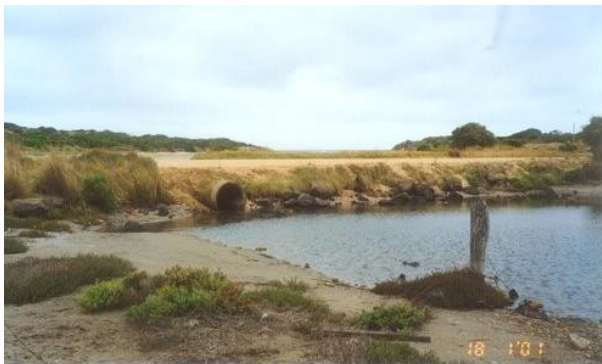
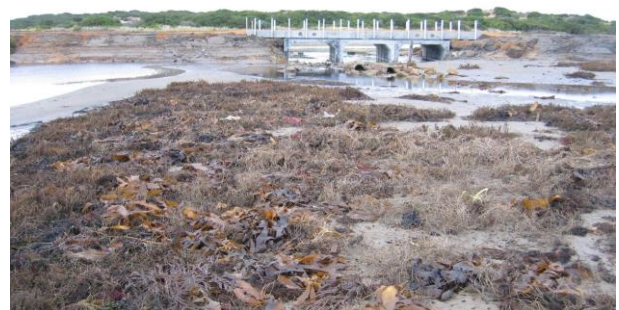
The Karaaf wetlands are connected to Thompson Creek estuary via Mullet Creek. The construction of the road in the 1950s reduced the connection between the creek and the estuary to a single pipe culvert (Figure 6). A series of larger culverts were installed in 2004 to improve tidal exchange (Figure 7).

Original culvert connection through Point Impossible Road

View of the new culverts during construction

Figure 6 Photos of the original culvert connection and the new culverts during construction

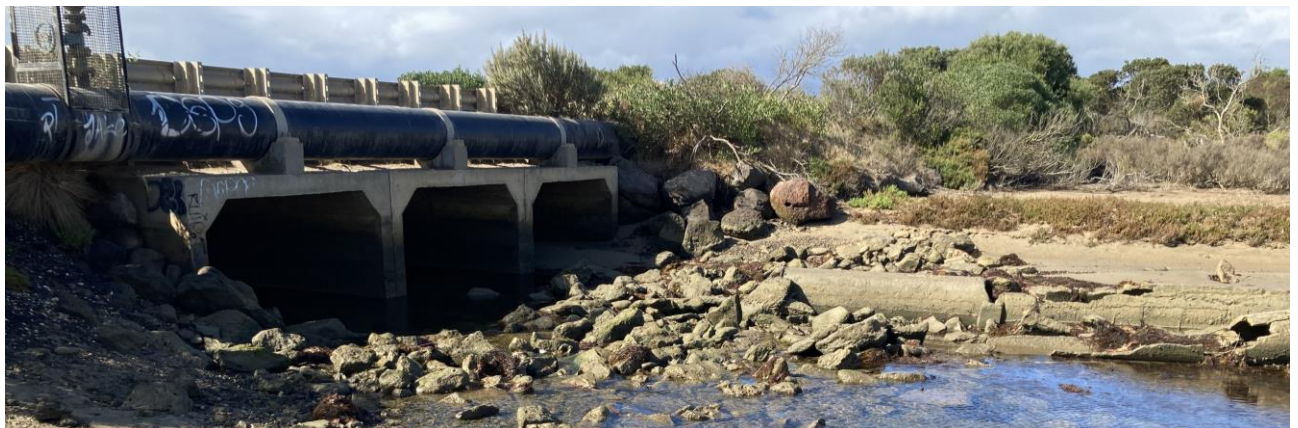
Figure 7 Photo of the culverts beneath Point Impossible Road connecting Mullet Creek to the Thompson Creek estuary

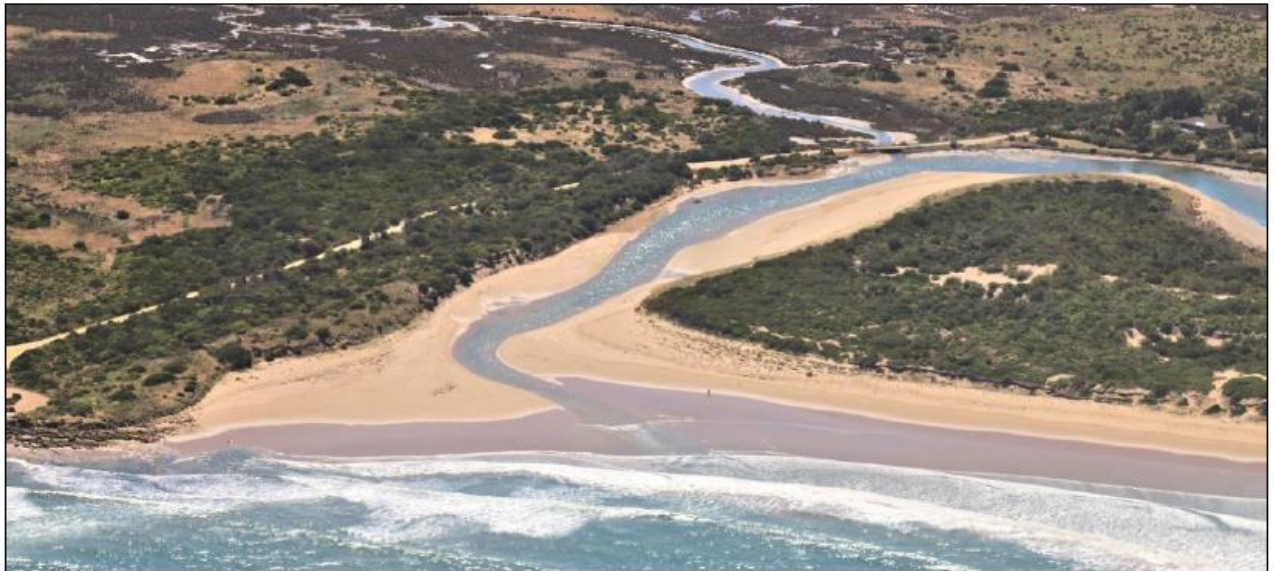
Thomson Creek is an intermittently open and closed estuary, which is the dominant estuary type in Victoria. When the mouth of Thomson Creek is open (Figure 8) tidal exchange occurs between the estuary and the ocean and between the estuary and Mullet Creek.

**Figure 8 Thomson Creek, Breamlea (N. Rosengren, 2016) in Barwon South West Scoping Study**

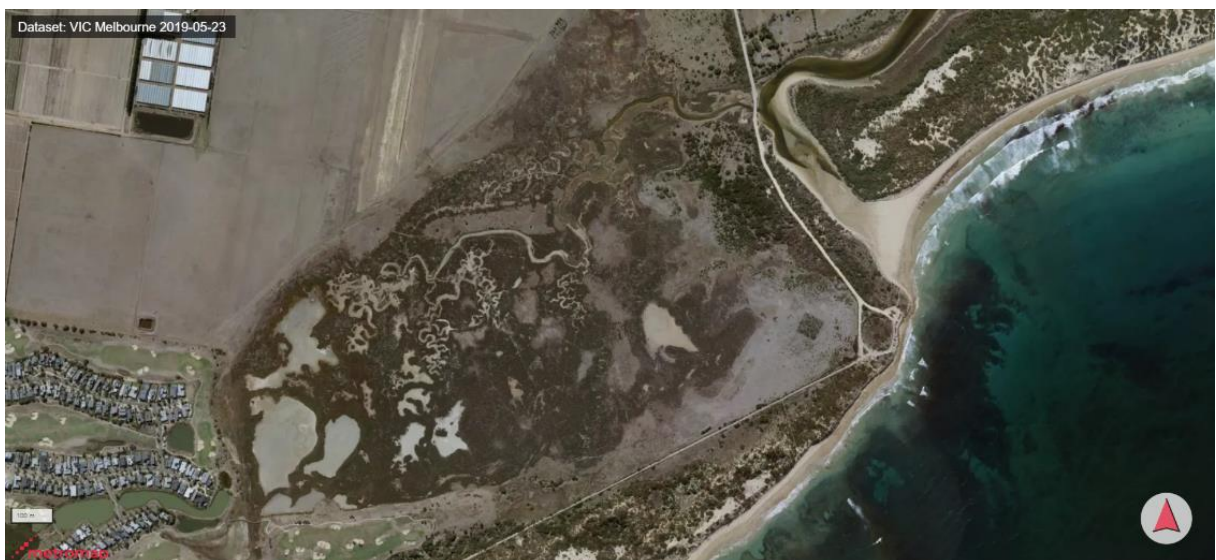
The mouth of the estuary closes (Figure 9) when there is low flow in the creek, and a beach berm builds up to separate the estuary from the ocean. If the mouth remains closed for a long time, any freshwater inflow builds up behind the berm and the water levels in the estuary rises.

Under these conditions, the water flowing through the culvert into Mullet Creek becomes increasingly fresh and the water level in the wetlands rises with the estuary.

**Figure 9 Aerial image from May 2019 showing the mouth of Thomson Creek closed**

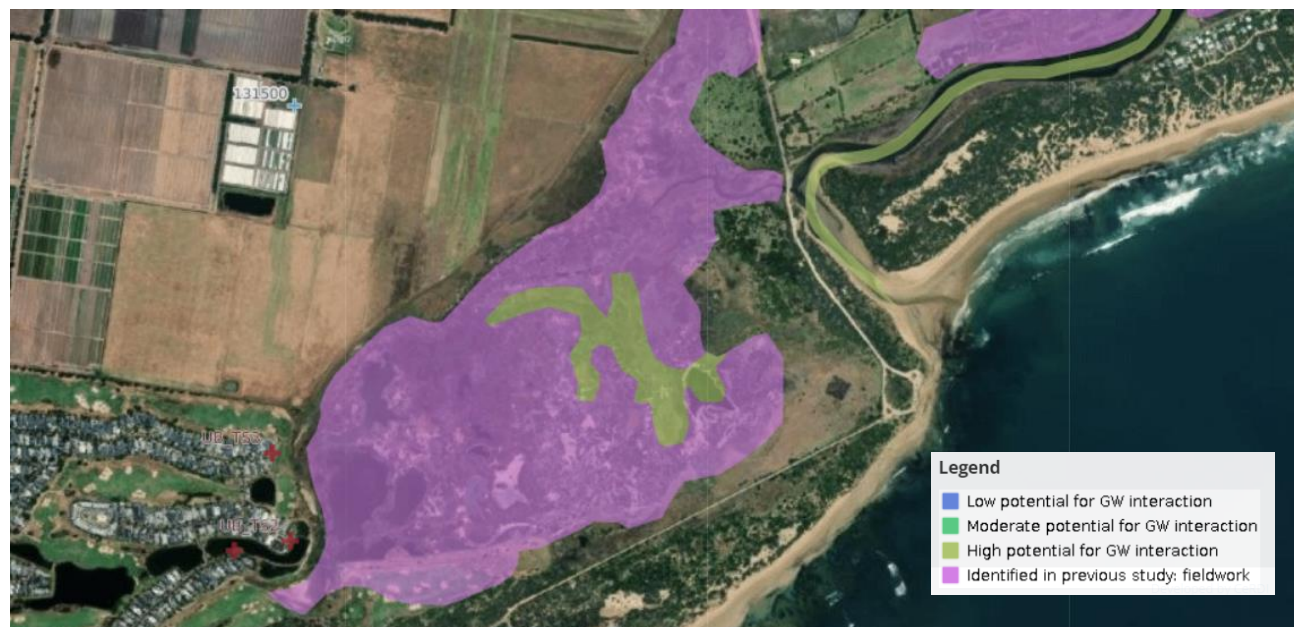
Depth to groundwater across the wetlands and adjacent areas is less than 5m and groundwater salinity is typically brackish (3,000 - 35,000 TDS) (A.S. Miner, 2008 as referenced in Pathways, 2022) and Visualising Victoria's Groundwater (<https://www.vvg.org.au/>). The Karaaf wetlands have been identified as a groundwater dependent wetland<sup>1</sup> (Figure 11).

Figure 11 Groundwater dependent terrestrial vegetation - Karaaf Wetlands (<https://www.vvg.org.au/>)

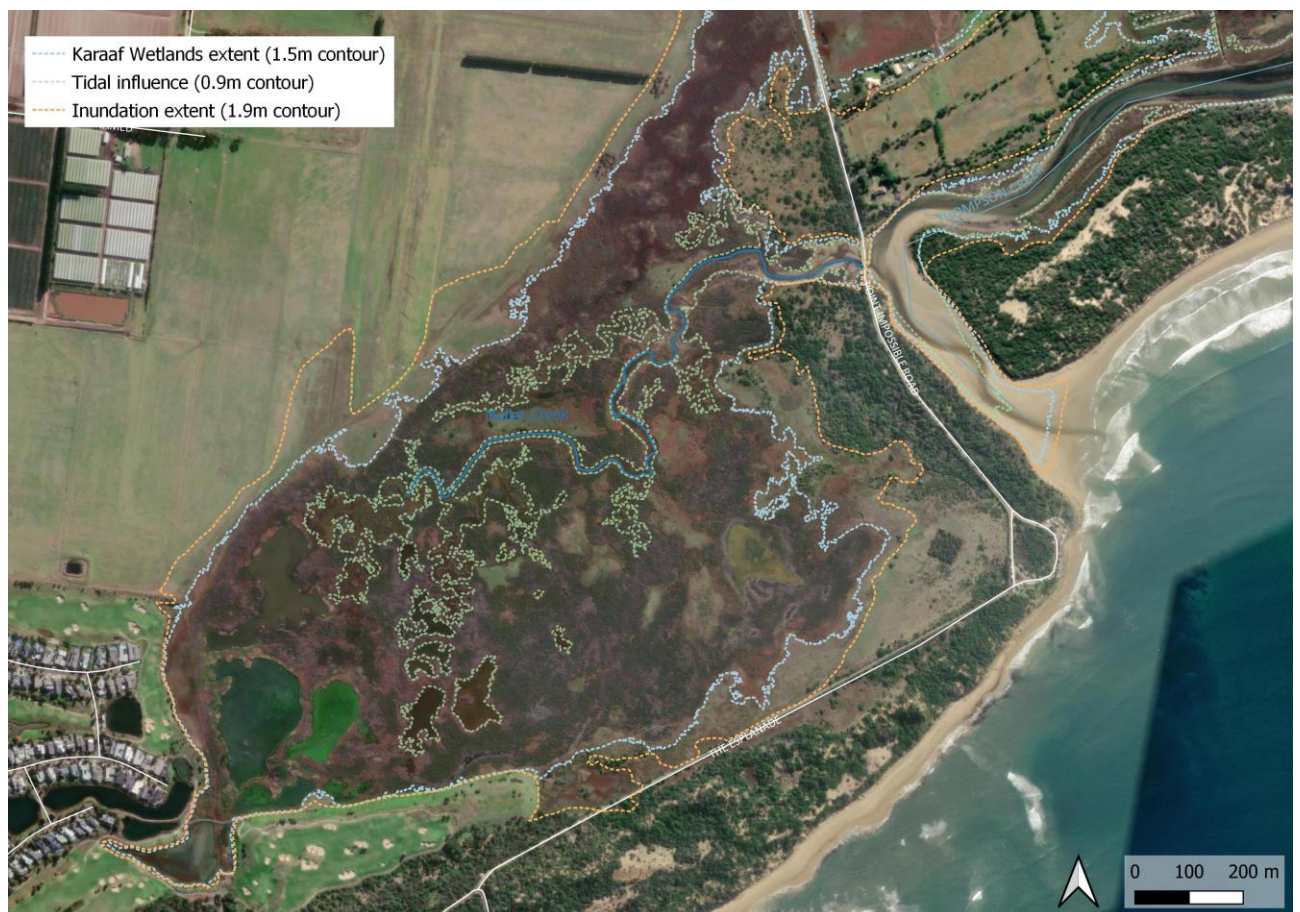
We can translate this into a tidal extent across the Karaaf wetlands by mapping these levels onto the elevation data, Figure 17. The 0.9 m contour (green) represents the area of the wetland that is regularly inundated by the tide. The 1.5 m contour (blue) represents an indicative upper limit of coastal inundation (entrance open) and matches well the general extent of the wetland.

Figure 17 Comparison of coastal water levels and elevations across the Karaaf wetlands

The most westerly area of the wetlands is above the typically tidal levels, and this aligns with the area most impacted by stormwater inflows through dieback of estuarine vegetation species (Figure 18). Any stormwater inflows to this most westerly area would not regularly interact with the tide and there are no tidal channels connecting these higher areas directly to Mullet Creek to allow the flows to drain directly into the creek.

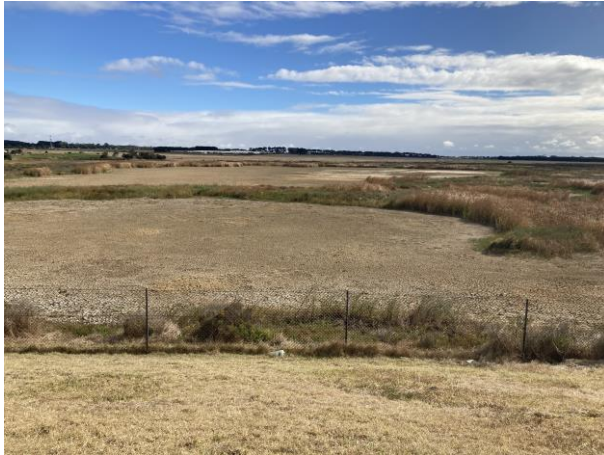
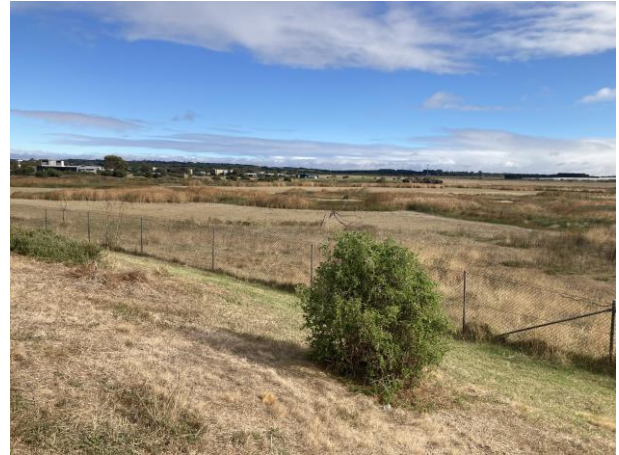
This is further supported by recent observations on site, where the westerly section of the wetlands was completely dry (Figure 19) despite the estuary mouth being open (Figure 20).

Figure 19 Views across the most westerly section of the Karaaf wetlands with dry clay pan areas (photo: 30/03/23)

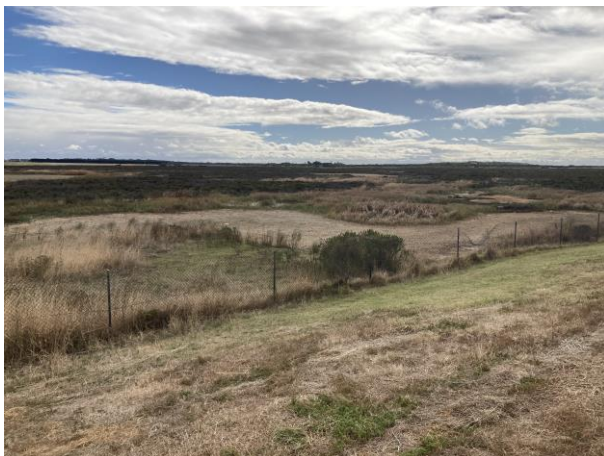
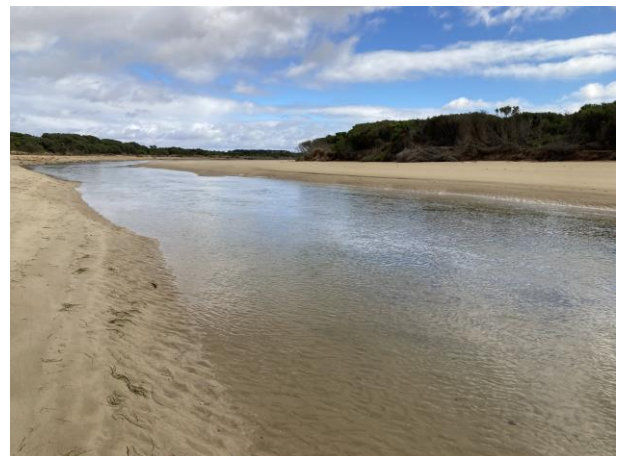
Figure 20 View looking towards the more easterly section of the Karaaf bordering Point Impossible Road (left) showing more varied vegetation communities and the current open mouth of the Thompson Creek (right) (photo: 30/03/23)

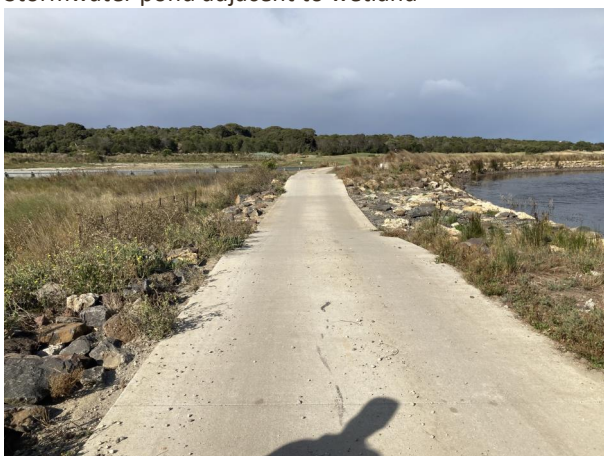
Stormwater pond overflow to wetland

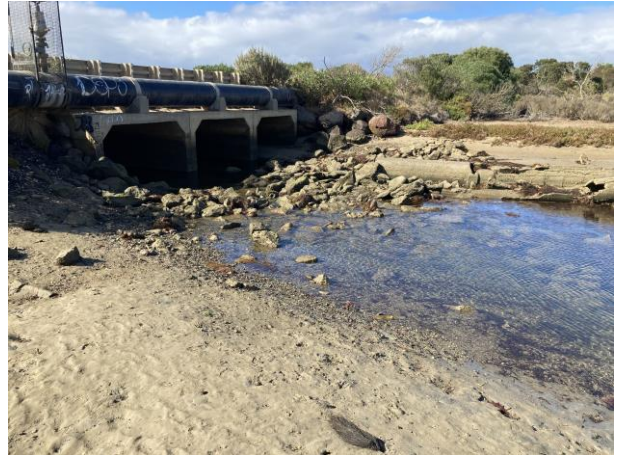
View of the culverts connecting Mullet Creek to the estuary
