# The Creeping Disaster Dryland and Urban Salinity and its Impact on Heritage

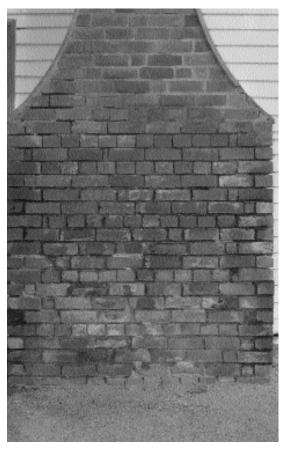
Rising damp and salt attack, chimney of cook house, Murray Downs Homestead, Swan Hill, NSW. Note the salt efflorescence at the bottom and the extent of the mortar loss. Photo by the author.

Moisture ingress, per se, does not present a major threat to a structure, but sets up conditions ripe for wet rot of timbers, flaking of renders, moulding of wall papers, and so forth. Compounding the problem of rising damp is that in urban salinity environments soluble salts from the ground water and soluble compounds from the material are carried with the rising moisture to the surface of the building material, adjacent to the external atmosphere. There, the water evaporates and the salts re-crystallise in the pore spaces or on the surface. As crystallised salts occupy a greater space than dissolved ones they set up great mechanical stress exceeding 138,000 kPa (20,000 psi), causing internal rupturing of the building fabric.<sup>8</sup> In addition, salts attract moisture—and by implication more salts in solution— leading to the growth of salt crystals ("blooms"). Over time, the masonry elements collapse (spall), setting up conditions for structural failures to occur.<sup>9</sup>
